Mt. Tom Generating Company Facility
200 Northampton Street, Holyoke

Coal Combustion Residuals Legacy Surface Impoundments- Initial Annual Inspection Report

Prepared for ENGIE North America, Inc.
August 2025

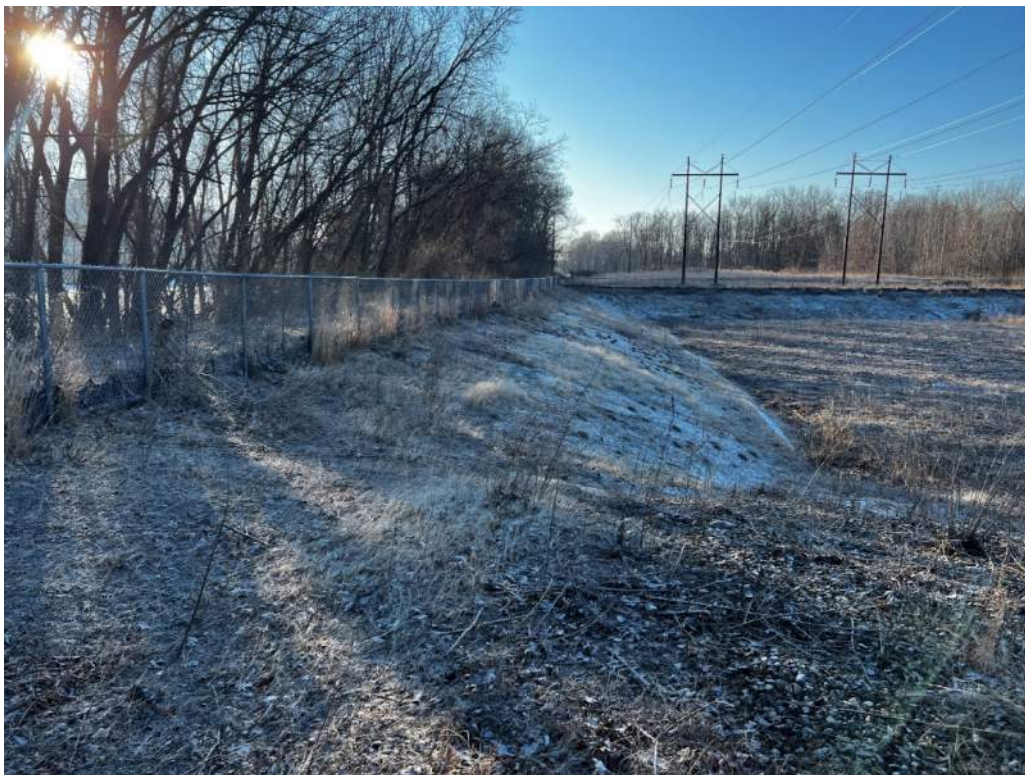
Photo 2 – East interior slope; note sparse vegetation

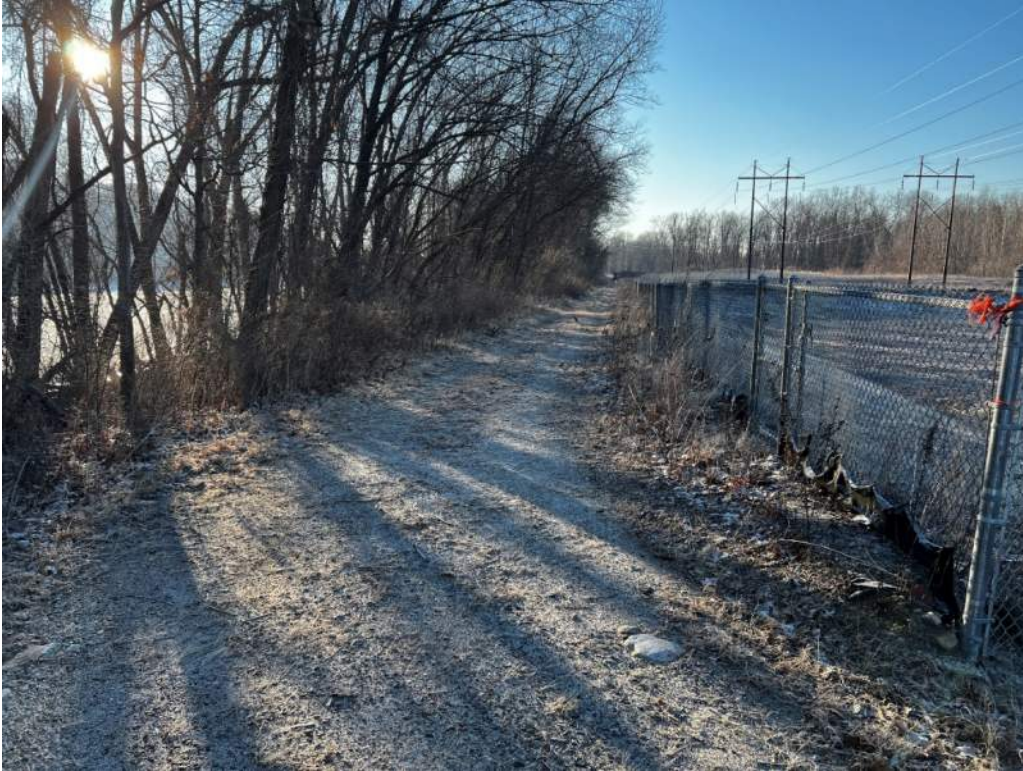
Photo 3 – Crest of east embankment; note sparse vegetation and minor rutting

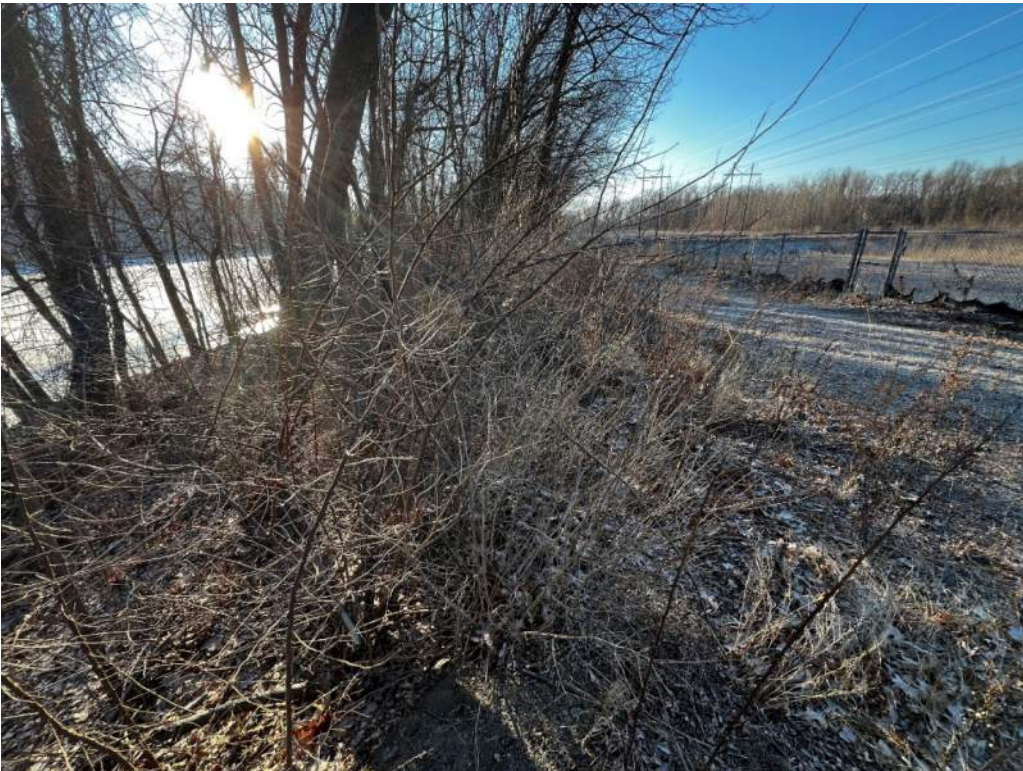
Photo 4 – East embankment exterior slope; note trees and brush

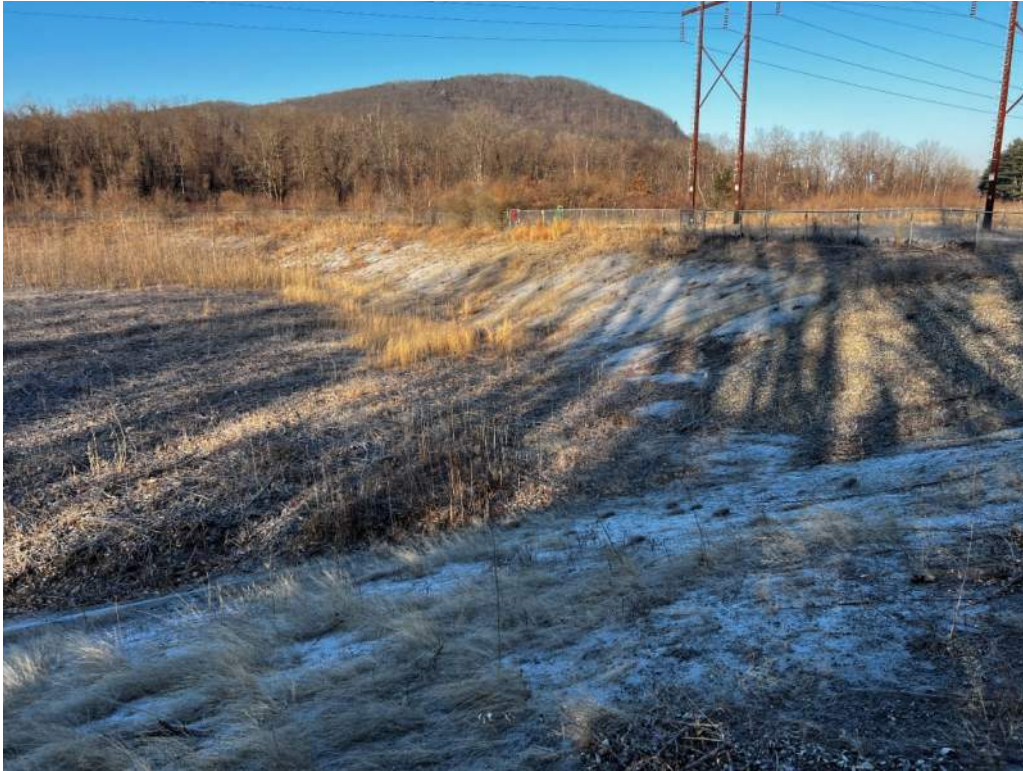
- The vegetation on the west slope exhibited sparse to fair coverage, although some brush is establishing.
 - The north slope exhibited minor erosion rills, particularly along its easterly end.

Photo 7 – North interior slope; note sparse vegetation

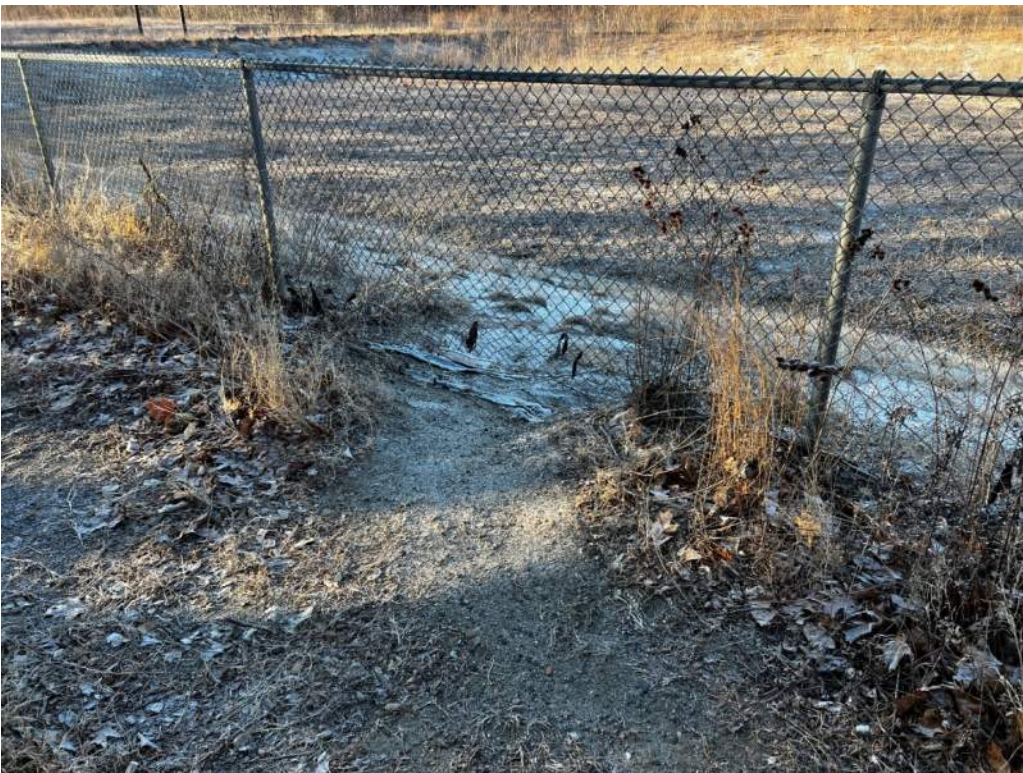
- The crest generally pitches away from the interior slope, reducing the contributory drainage area to the basin.
 - One low point was present along the eastern side, where the runoff appears to have eroded the crest causing drainage into the basin.

Photo 8 – Low, eroded area at upstream edge of crest on east embankment

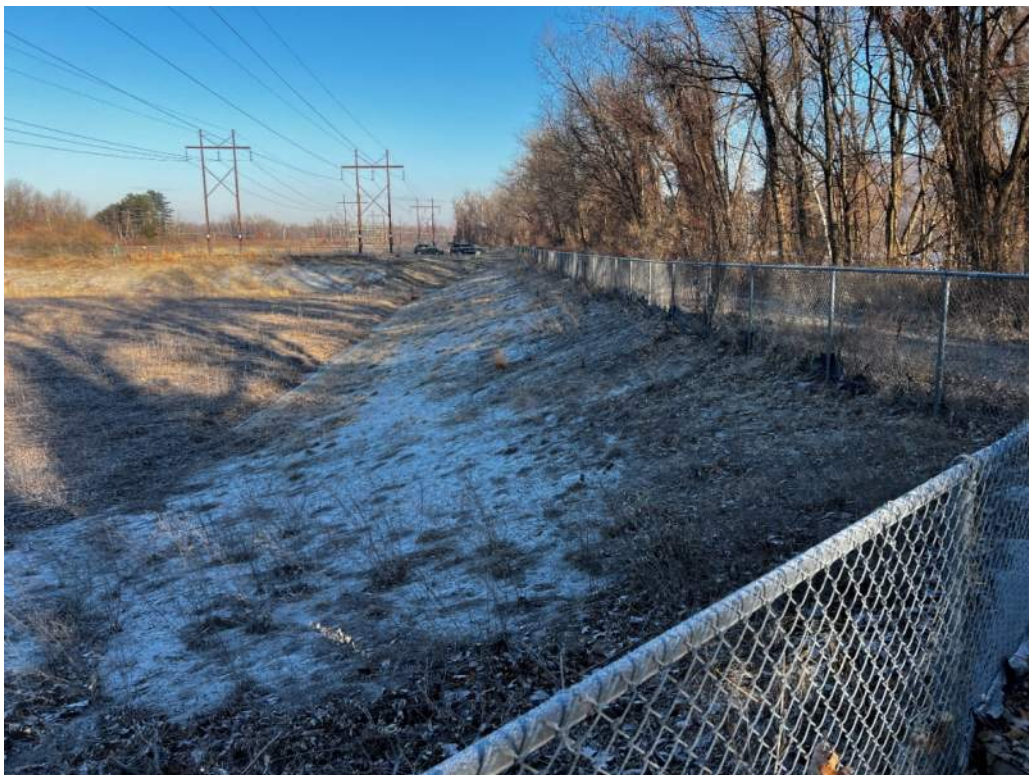
Photo 10 – Marginal vegetation along south portion of east interior slope

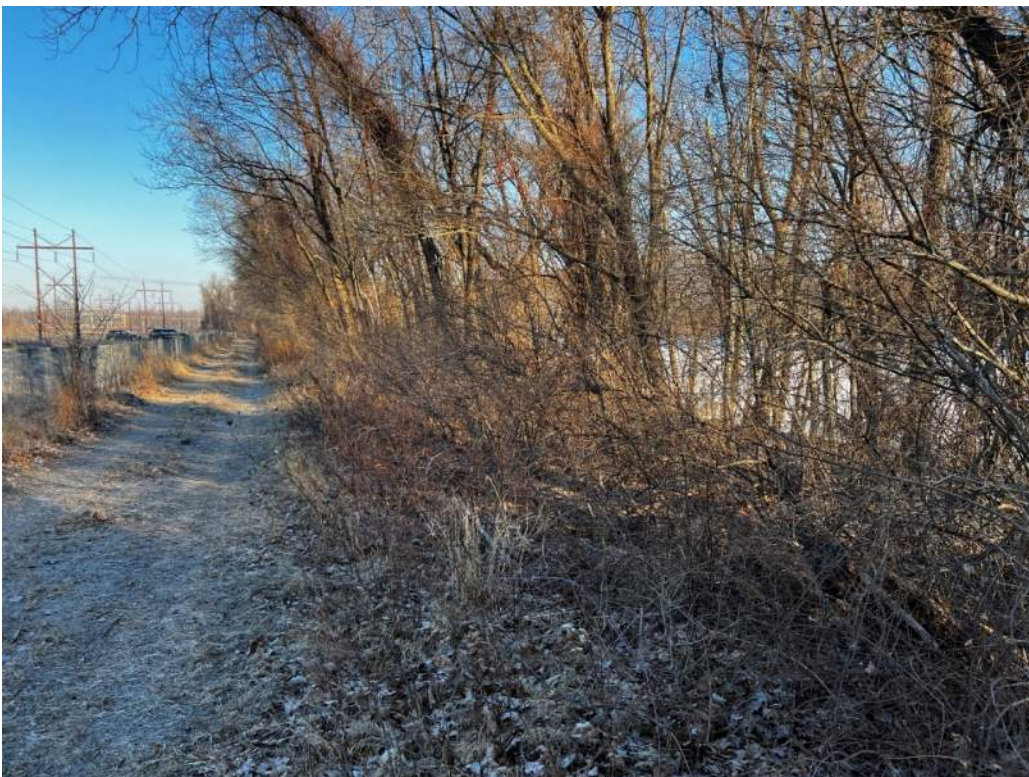
Photo 12 – East exterior slope from south; note heavy trees and brush

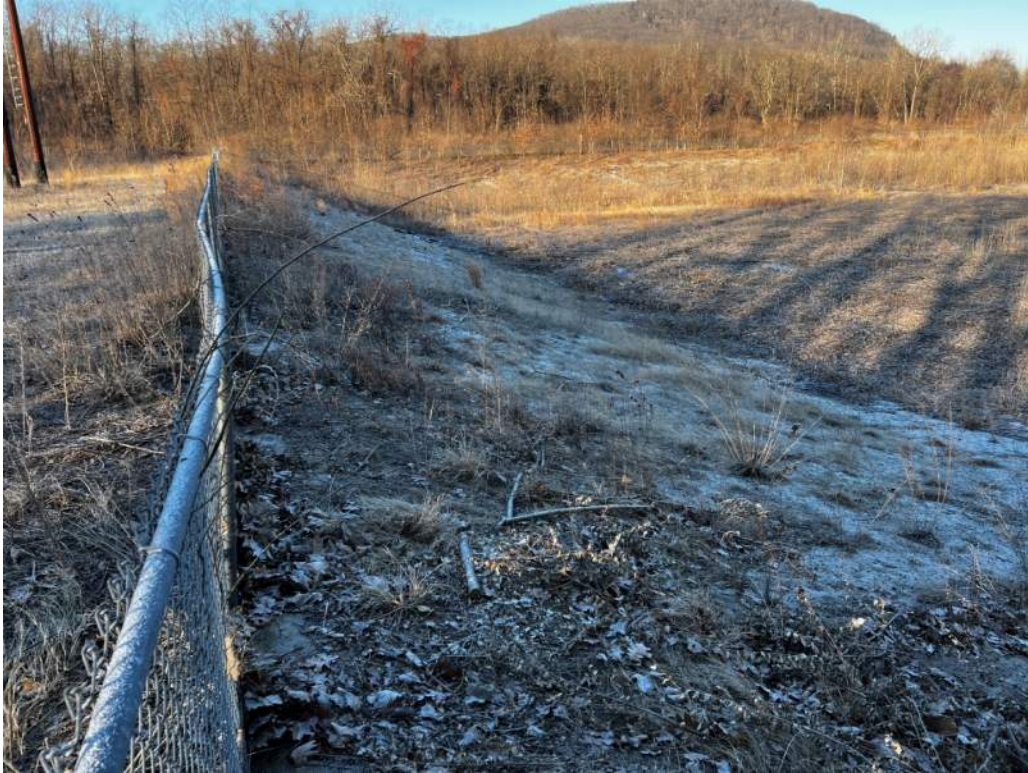
Photo 13 – South interior slope; note marginal vegetation

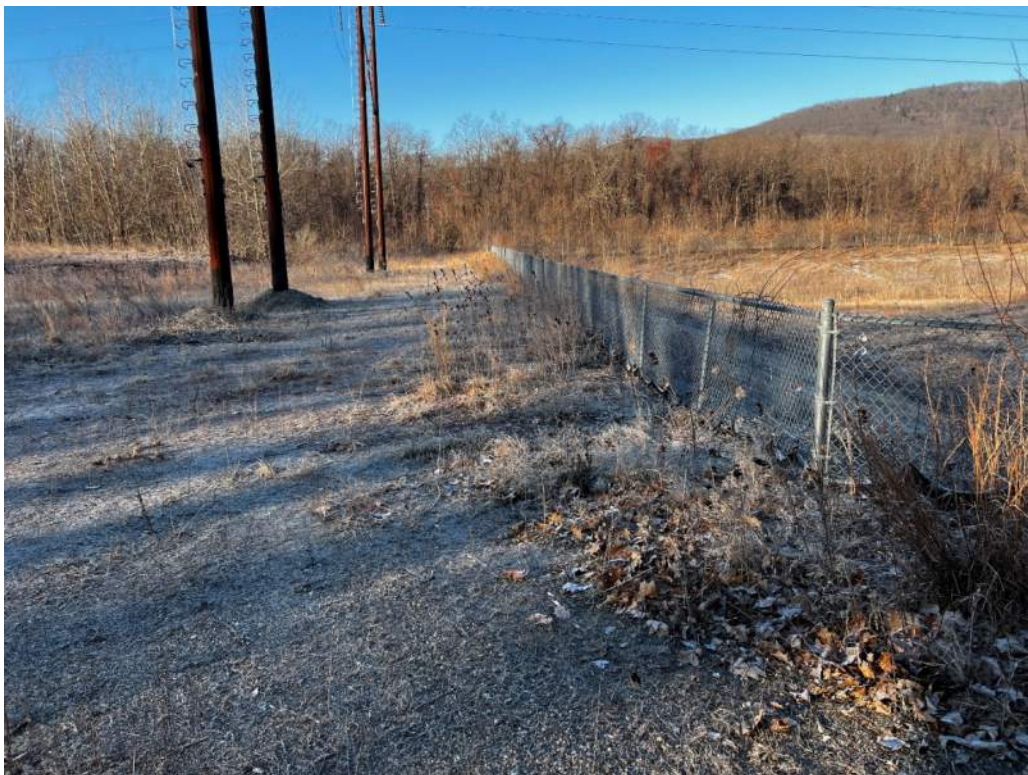
Photo 14 – South embankment; note marginal vegetation

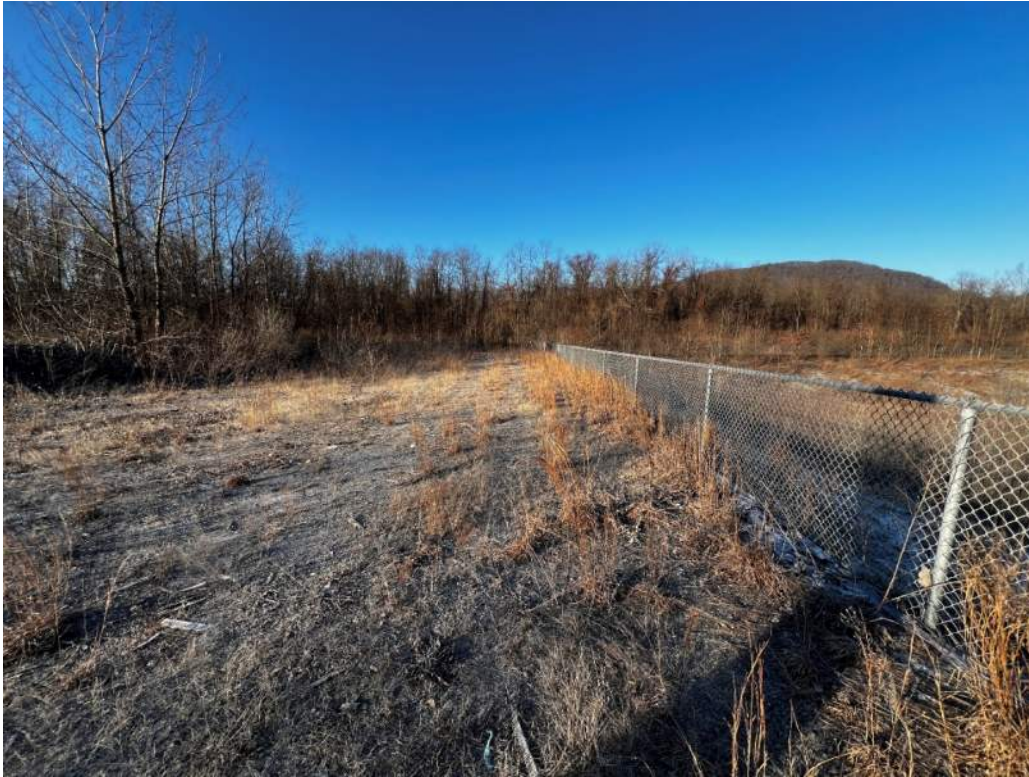
Photo 15 – South embankment; note marginal vegetation

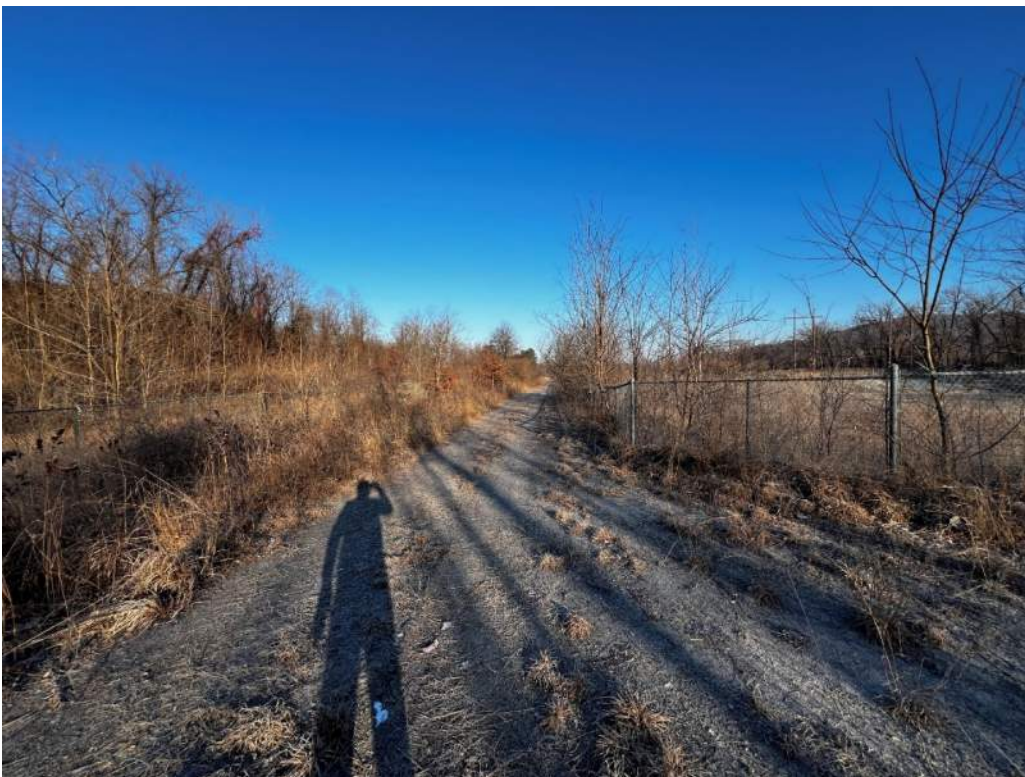
Photo 18 – West embankment looking north; note woody vegetation along interior slope

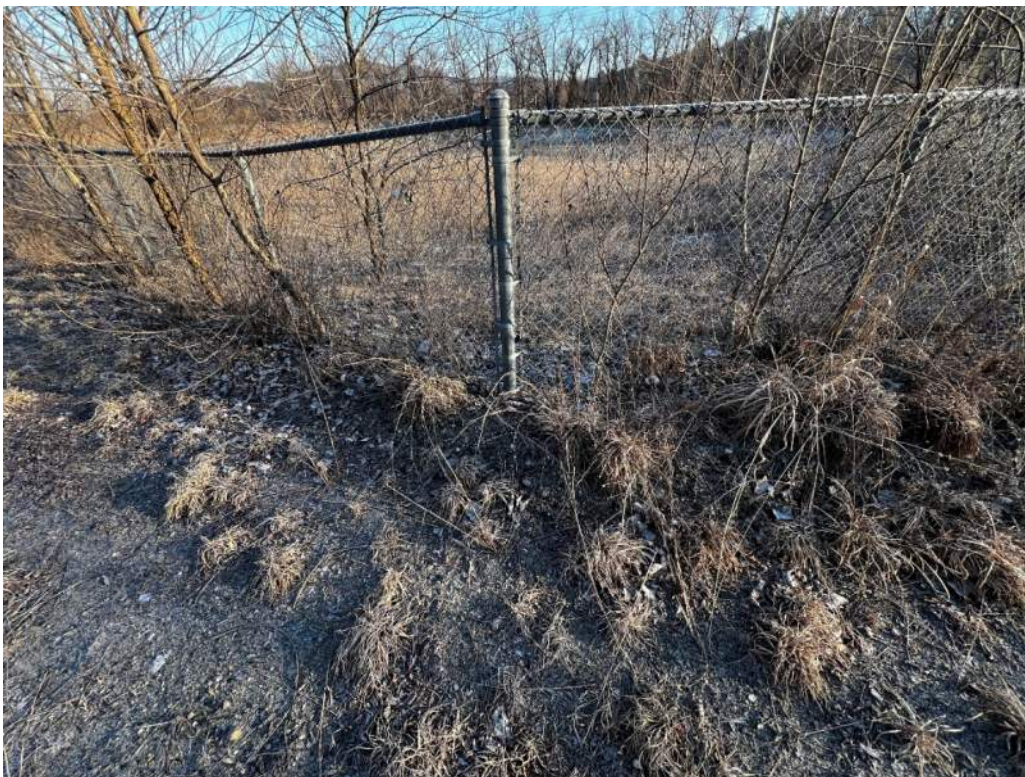
- The fence had areas of minor damage; however, the fencing remains functional for Site security (see Photo 20 in Appendix A).

Photo 20 – Bending of fence section, potentially due to mechanical contact (e.g., fallen tree or construction equipment)

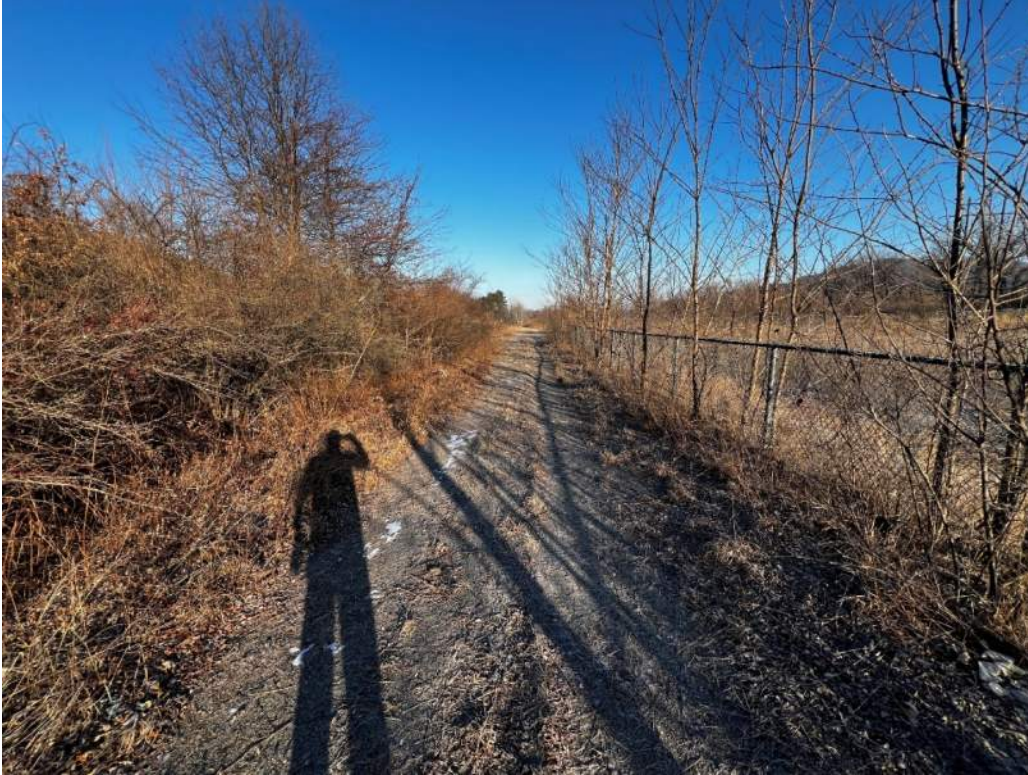
Photo 21 – West embankment looking north; note woody vegetation along interior slope

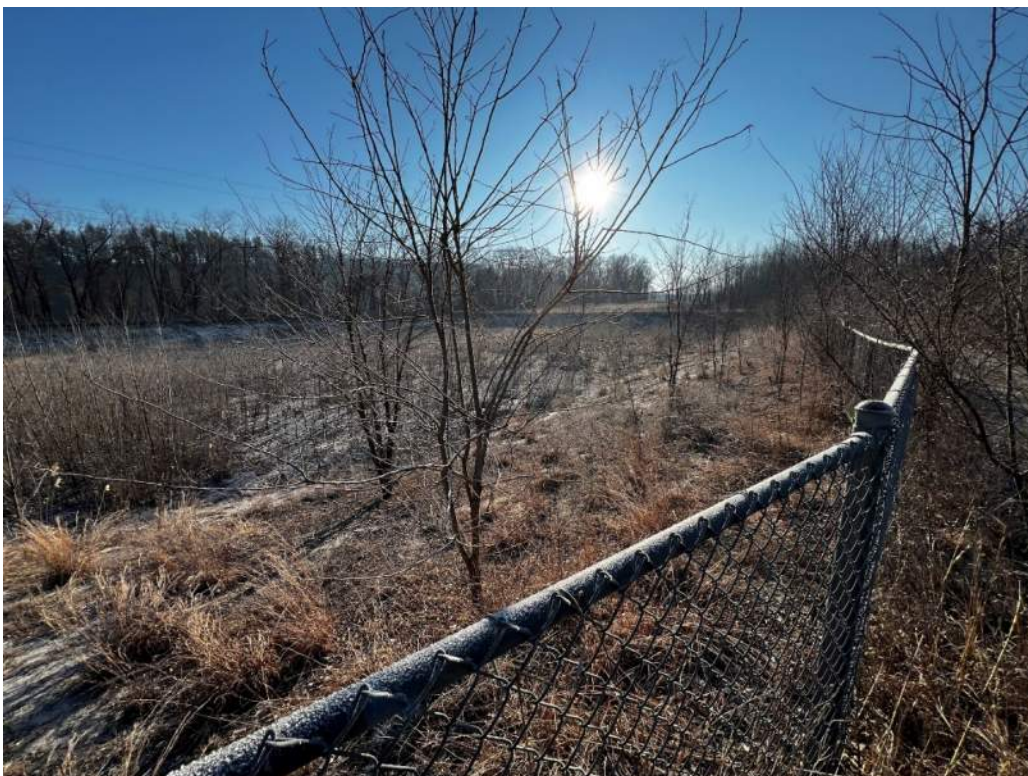
Photo 22 – West interior slope; note woody vegetation

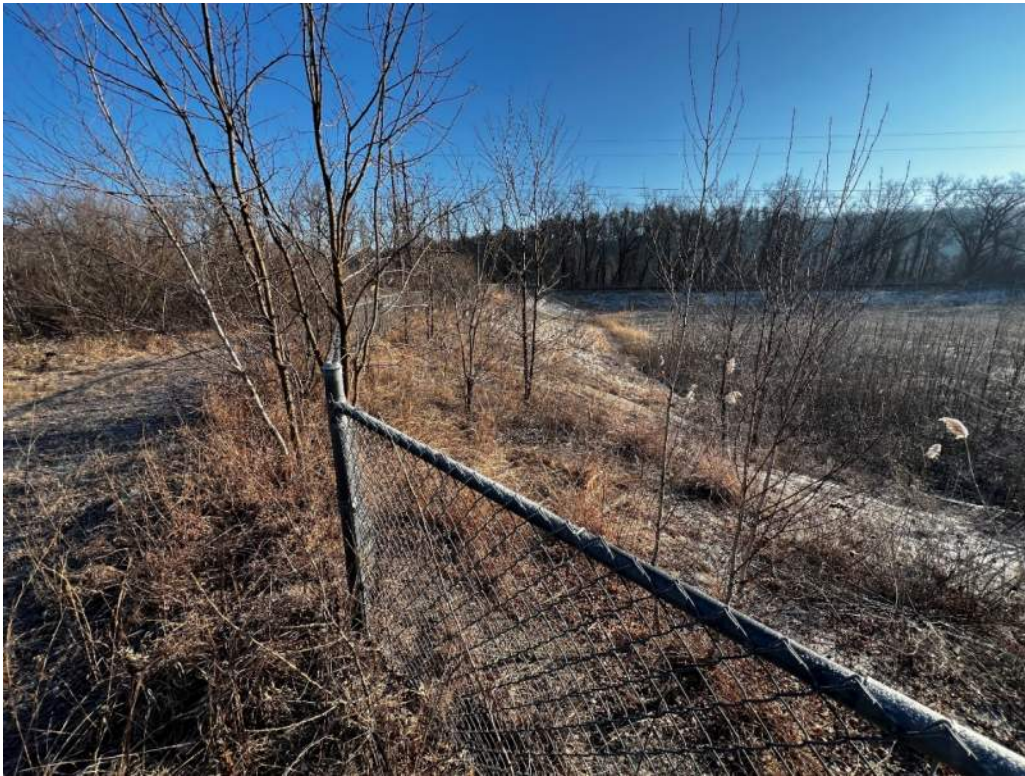
Photo 23 – South interior slope; note woody vegetation and areas of sparse cover

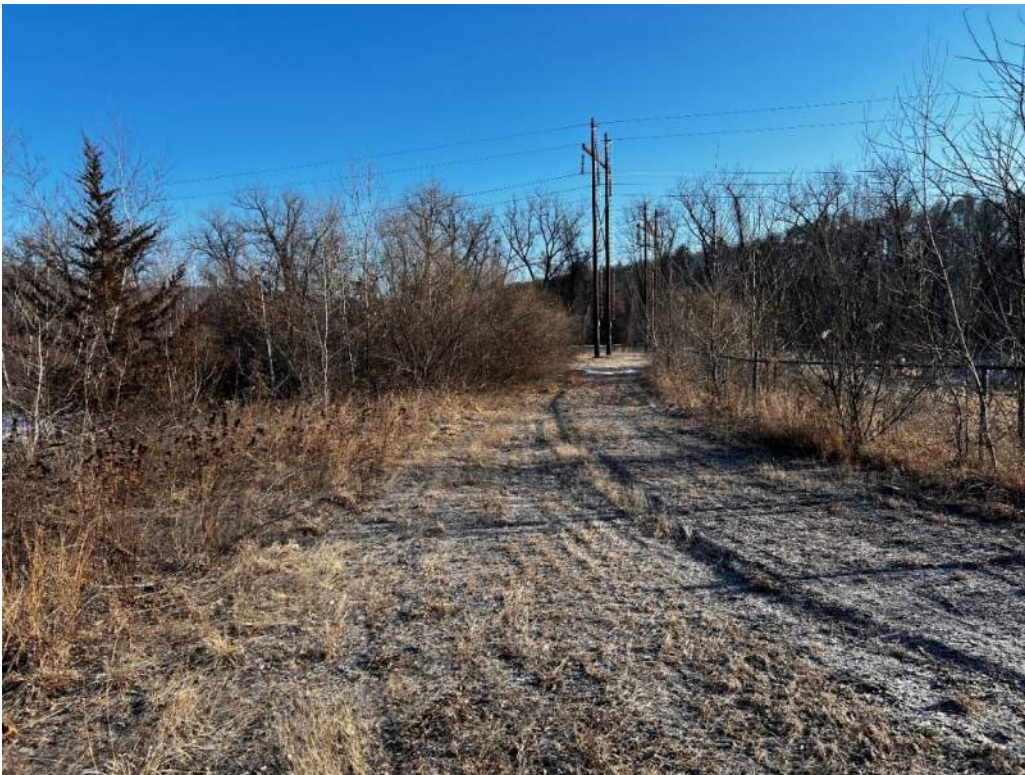
Photo 24 – South crest; note brush

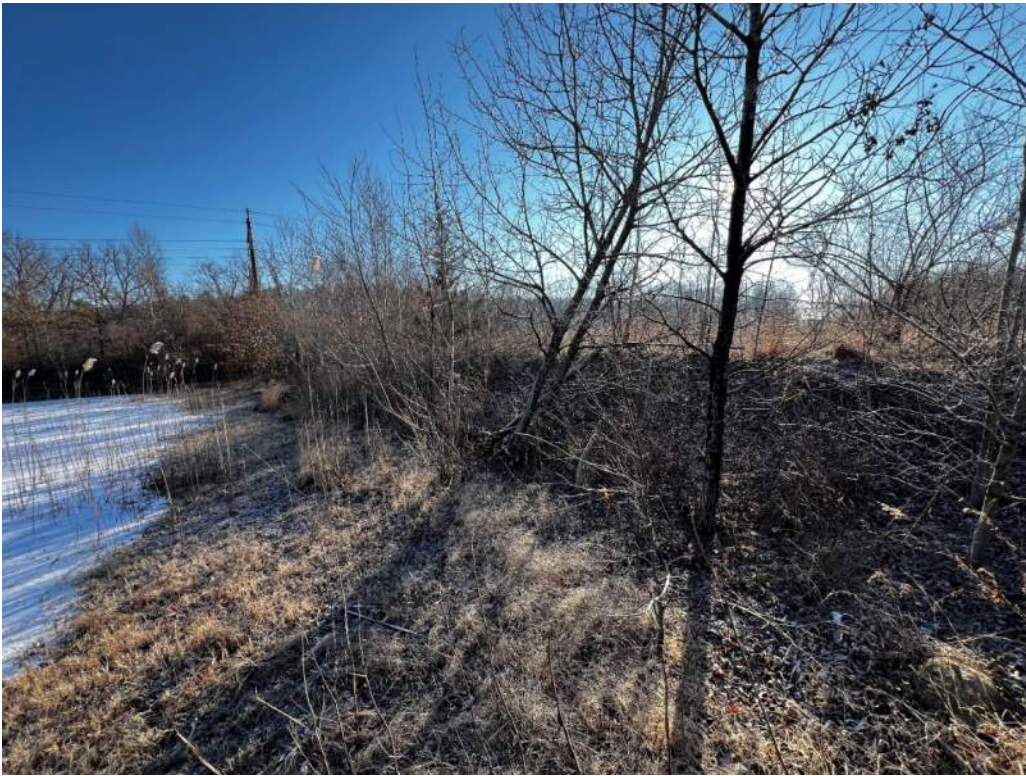
Photo 25 – North exterior slope along coal pile sump; note woody vegetation

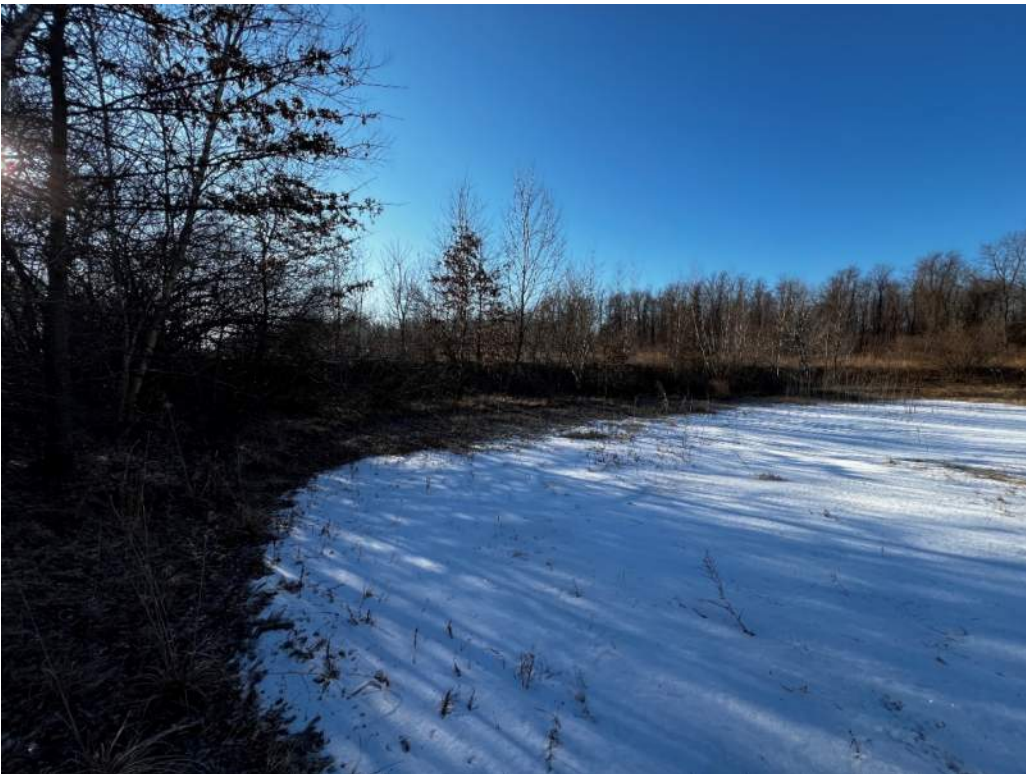
Photo 26 – North exterior slope along coal pile sump; note woody vegetation

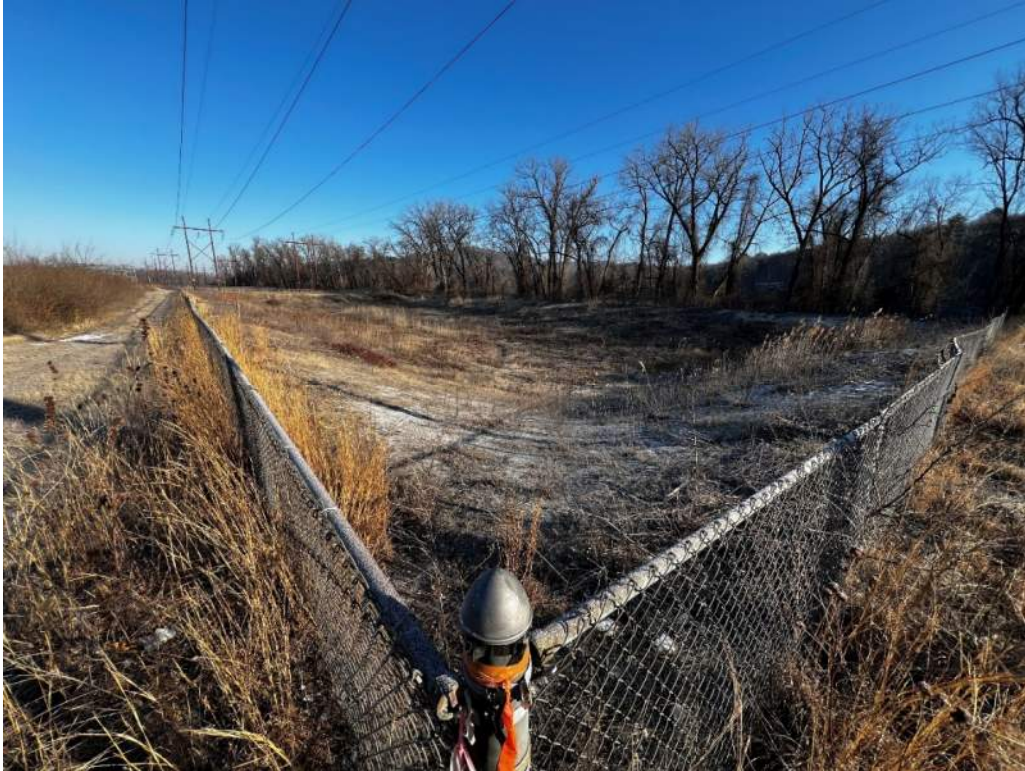
Photo 1 – Overview of Special Basin from southwest corner; note sparse vegetation on slope

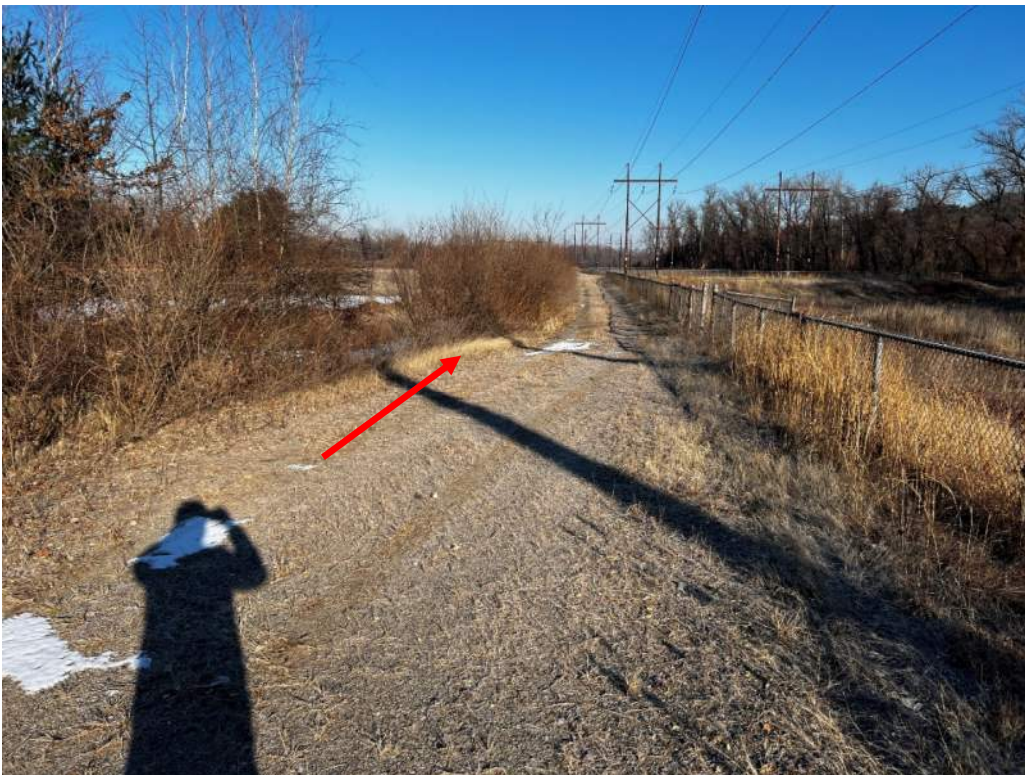
- The south crest is wide and covered with gravel.
 - The west crest is covered with a combination of gravel and sparse vegetation. Two low areas are present along the vehicle ruts.

Photo 2 – West embankment crest looking north; note low area (red arrow)

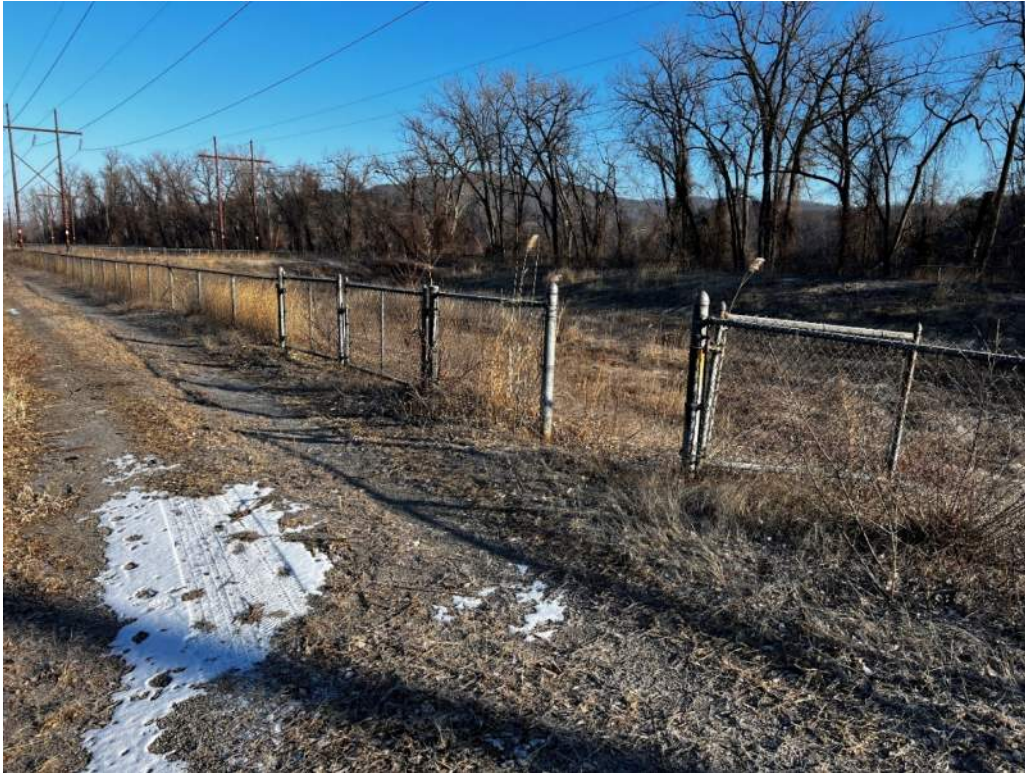
Photo 3 – Open gate in fence along west embankment

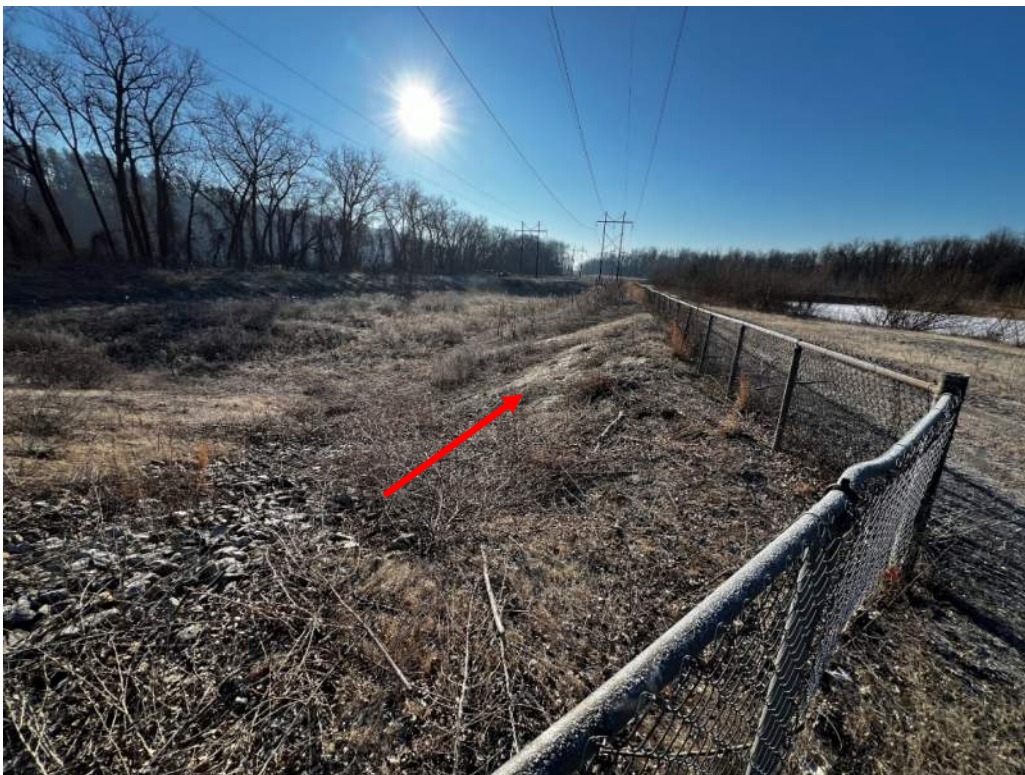
- An area of marginal vegetative cover is present along the west interior slope near its north end.
 - Riprap is present at the west end of the north interior slope. The center portion of this slope has marginal vegetative cover.

Photo 4 – Interior slope of west embankment looking south; note area of marginal vegetation (red arrow) and riprap in lower left of photo

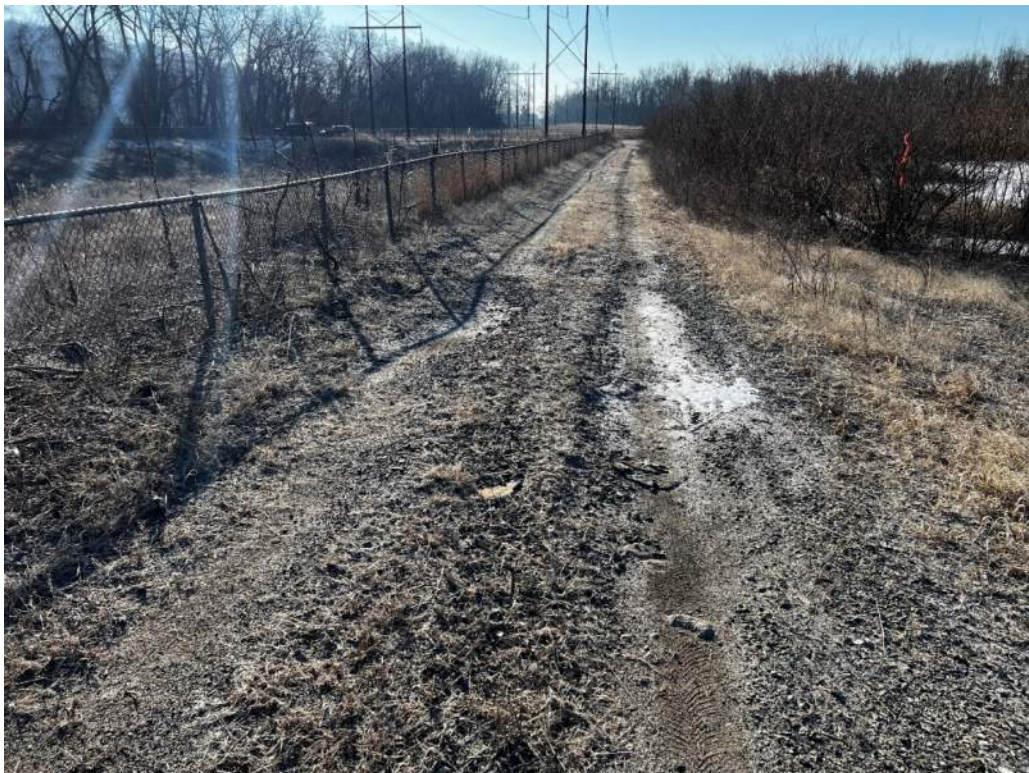
Photo 6 –Low area with rutting on west crest

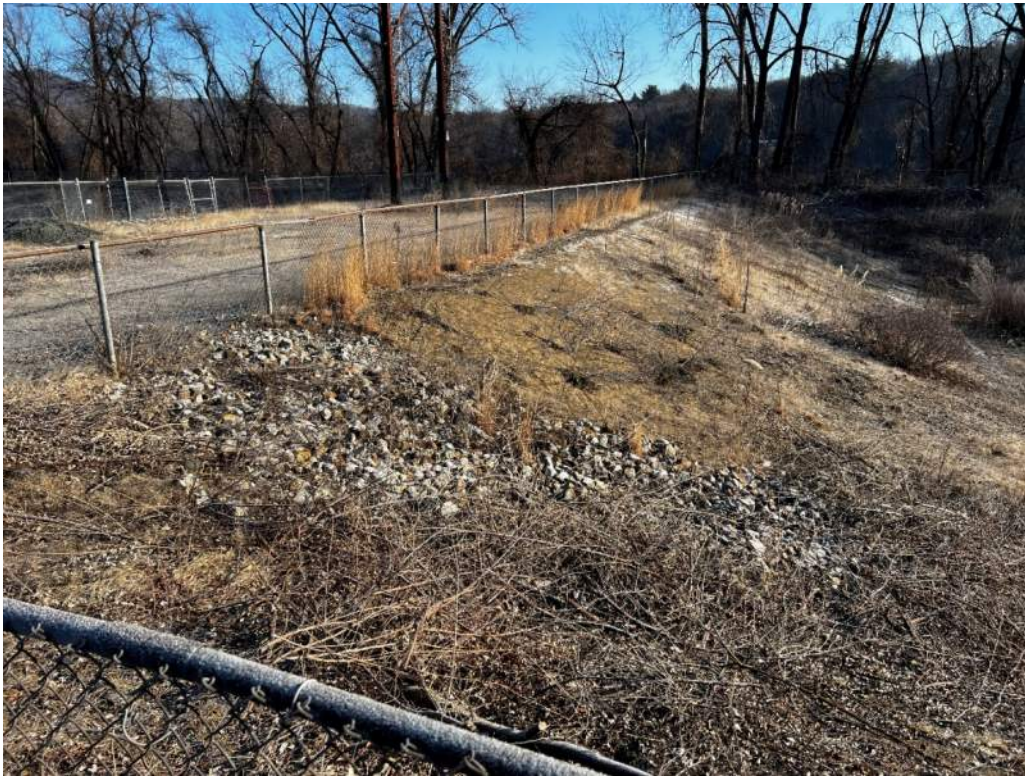
Photo 9 – Interior slope of north embankment; note riprap on slope and sparse vegetation

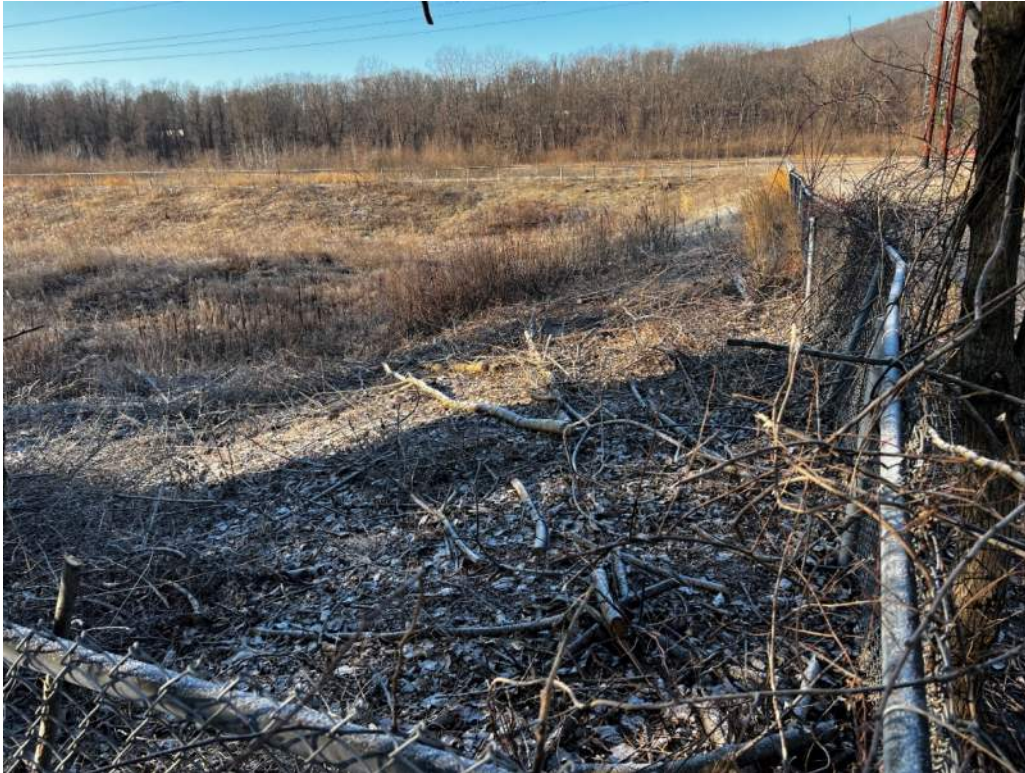
- The fence had areas of minor damage; however, the fencing remains functional for Site security (see Photo 11 in Appendix B).

Photo 11 – North embankment interior slope; note cut vegetation

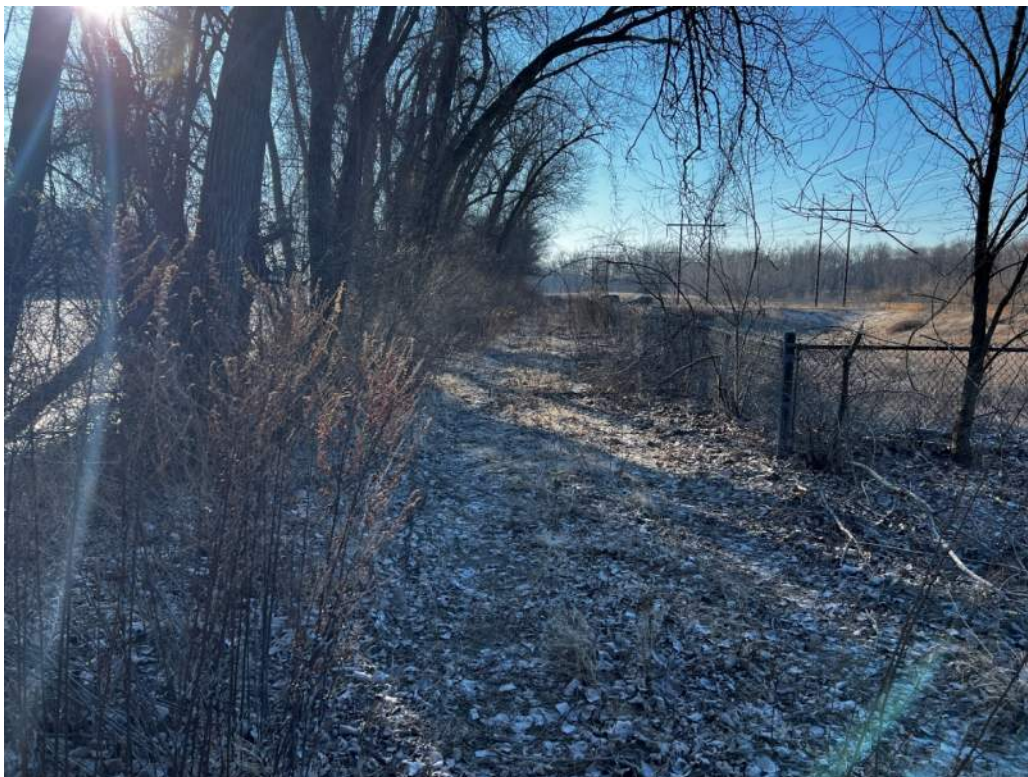
- The north embankment crest is wide and covered with a combination of gravel and sparse vegetation.
 - The east crest is narrow and moderately vegetated. Brush is encroaching on both sides along the majority of its length.

Photo 12 – East embankment crest looking south; note trees on exterior slope and brush growing along fence line.

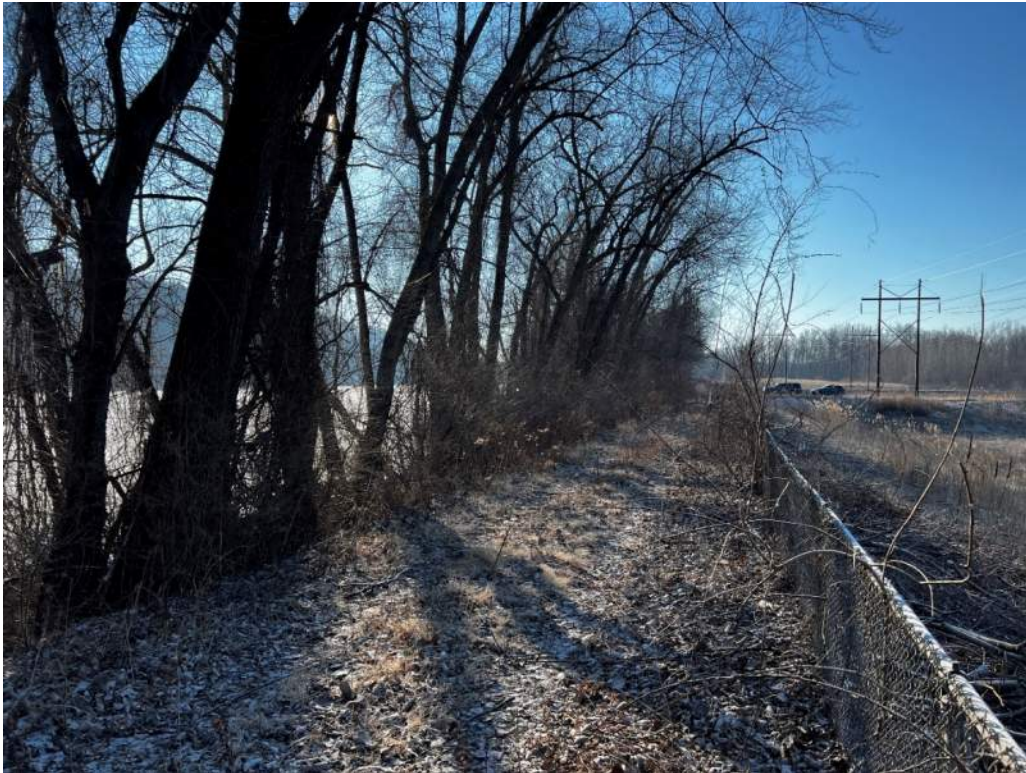
Photo 15 –East embankment crest; note minor rutting

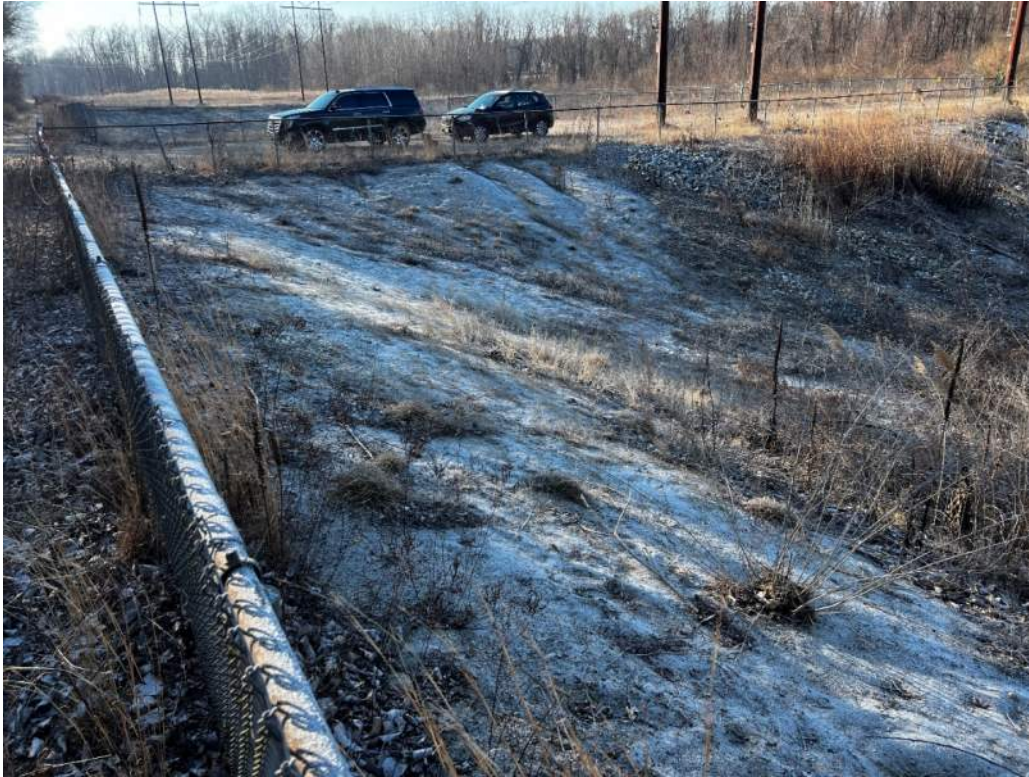
Photo 17 – Junction of east interior slope and south interior slope; note marginal vegetative cover and erosion rills
