Mt. Tom Generating Company Facility
200 Northampton Street, Holyoke

Coal Combustion Residuals Legacy Surface Impoundments- Initial Annual Inspection Report

Prepared for ENGIE North America, Inc.
August 2025

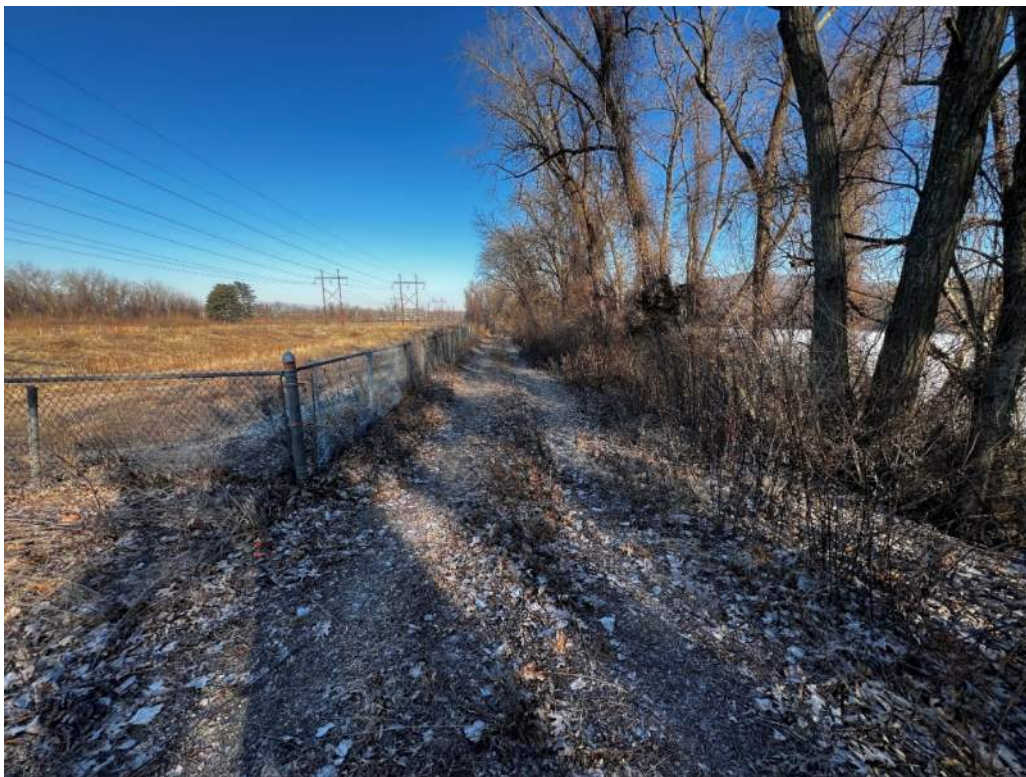
Photo 20 –East crest; note trees on exterior slope
