Former Mt. Tom Station Power Plant  
200 Northampton Street  
Holyoke, Massachusetts

**Coal Combustion Residuals  
Legacy Surface Impoundments-  
Annual Inspection Report**

**Mt. Tom Generating Company LLC  
Houston, Texas**

August 2026

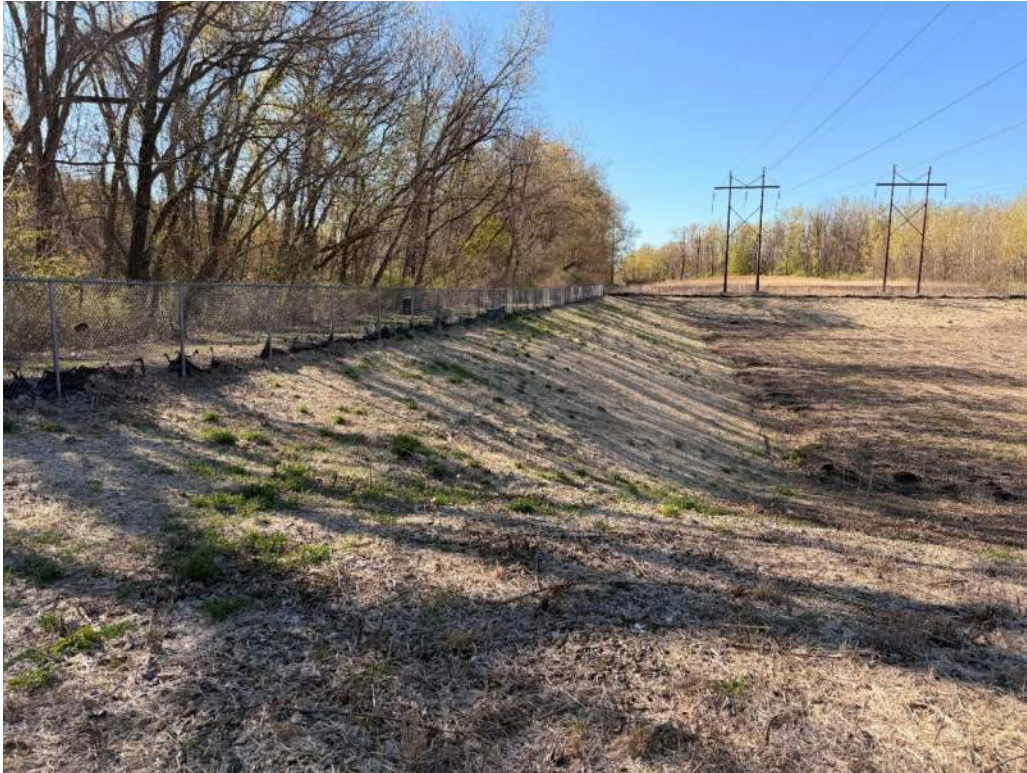
**Photo 1 - Bottom Ash Basin A east interior slope; vegetation remains sparse but area has been seeded and mulched**

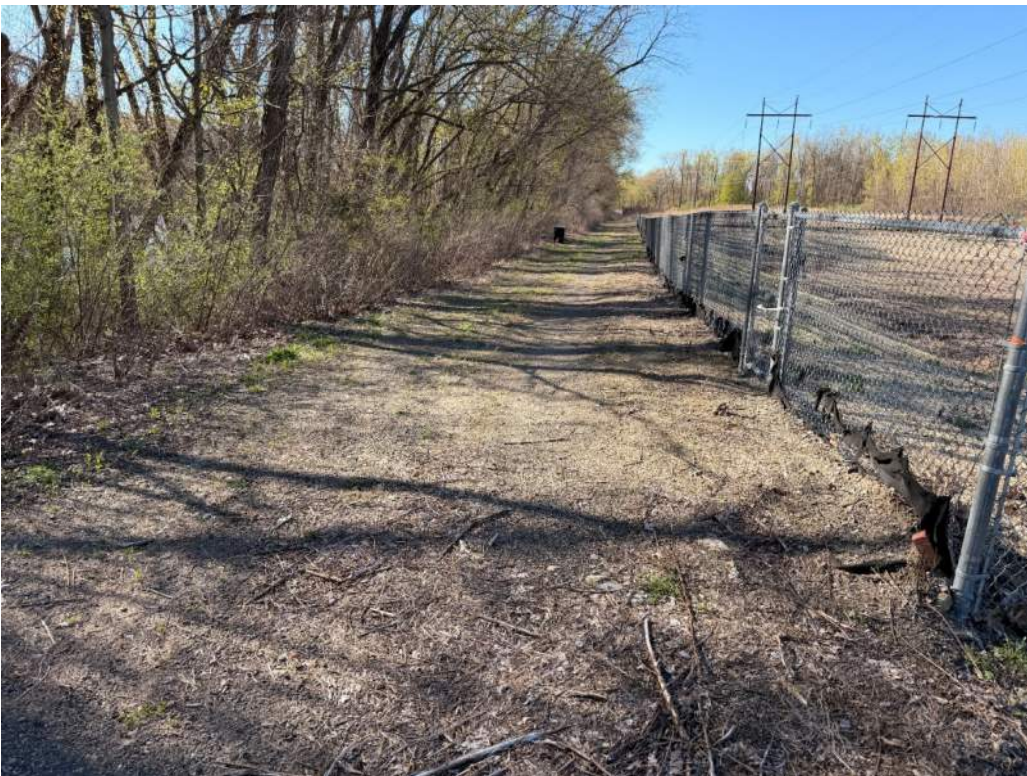
**Photo 2 - East embankment crest; note sparse vegetation and minor rutting**

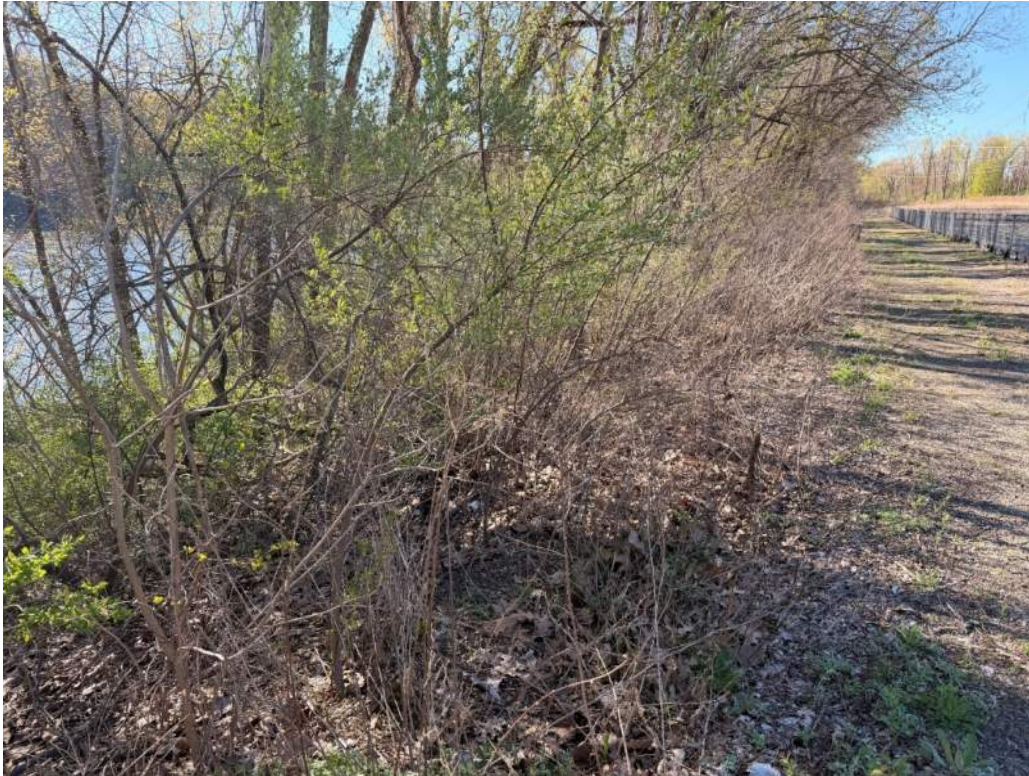
No significant additional structural weaknesses were identified. Visually-evaluated disruptive conditions remain, which include trees growing on the eastern, western, and northwestern exterior slopes. One area of minor erosion was noted along the interior edge of the south embankment crest.

**Photo 3 - East embankment exterior slope; note trees and brush**

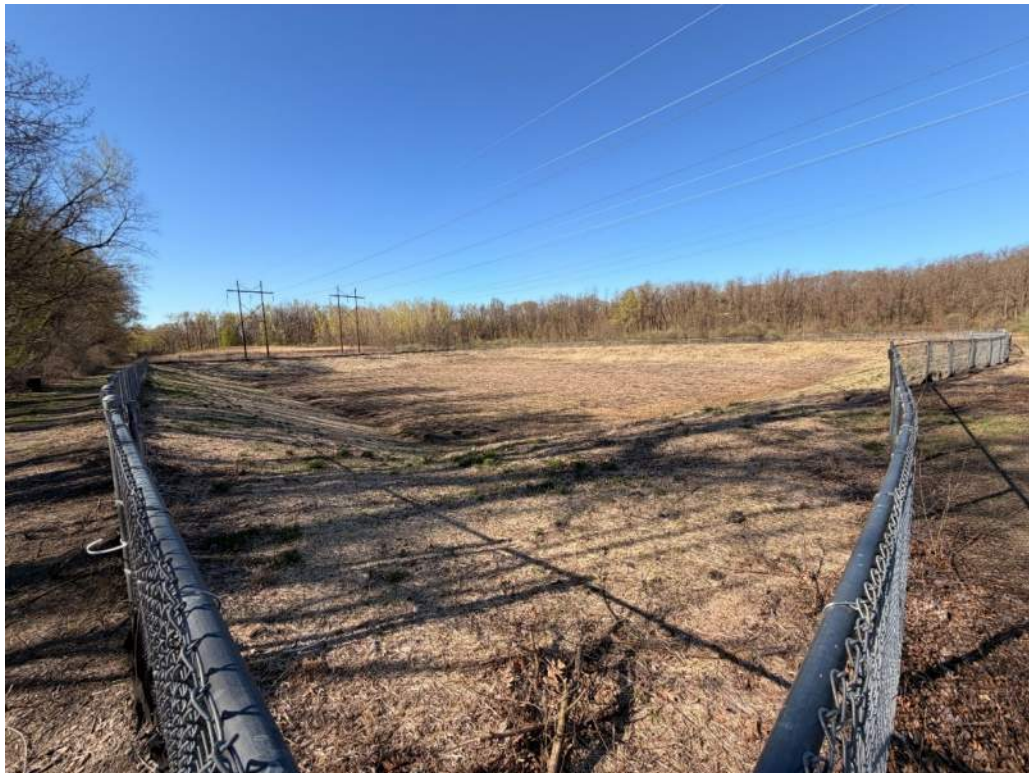
**Photo 4 - Interior of basin from northeast corner**

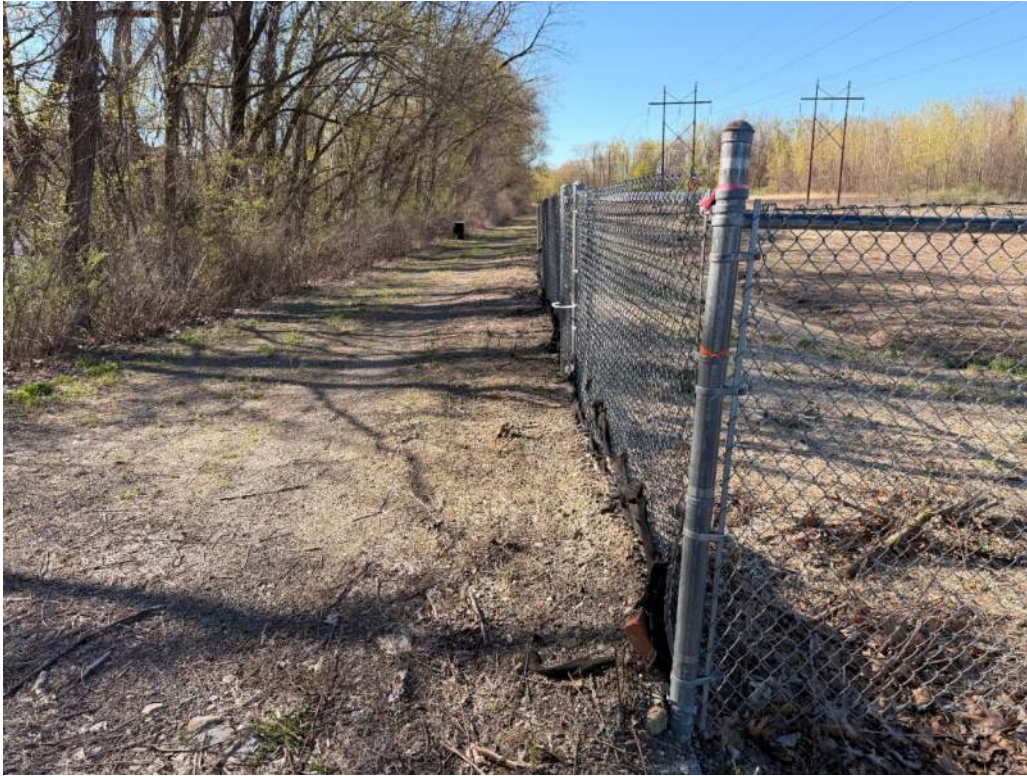
**Photo 5 - Berm along top of interior slope**

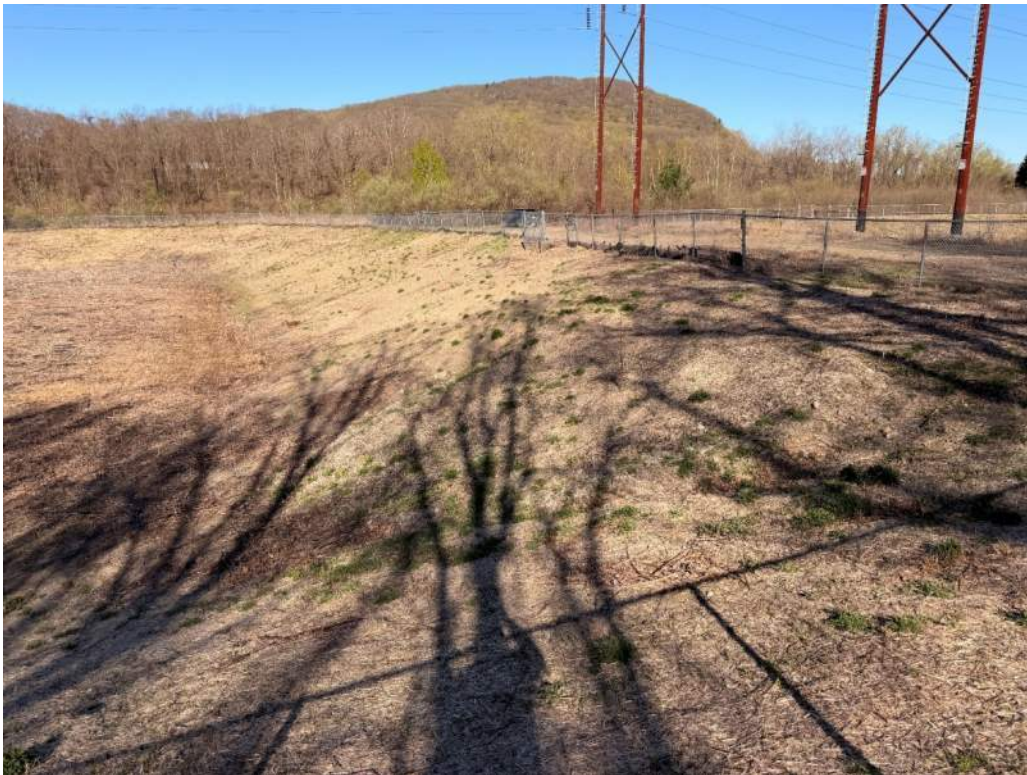
**Photo 6 - North interior slope; vegetation remains sparse but area has been seeded and mulched.**

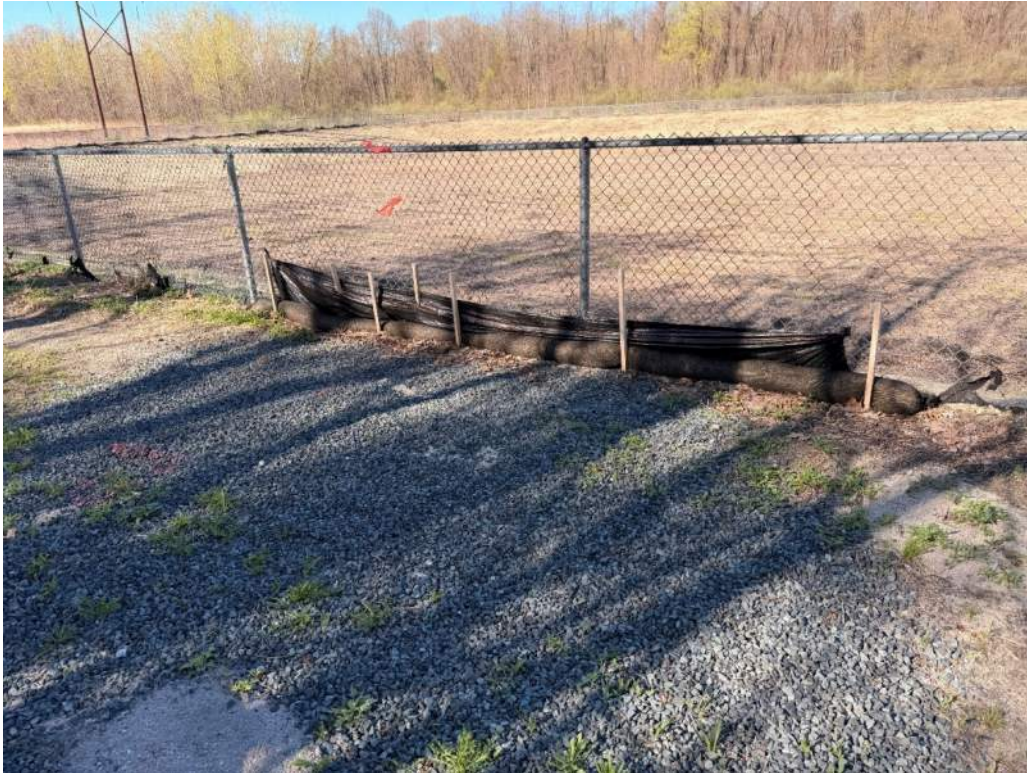
**Photo 7 - Repaired area that was previously low and eroded**

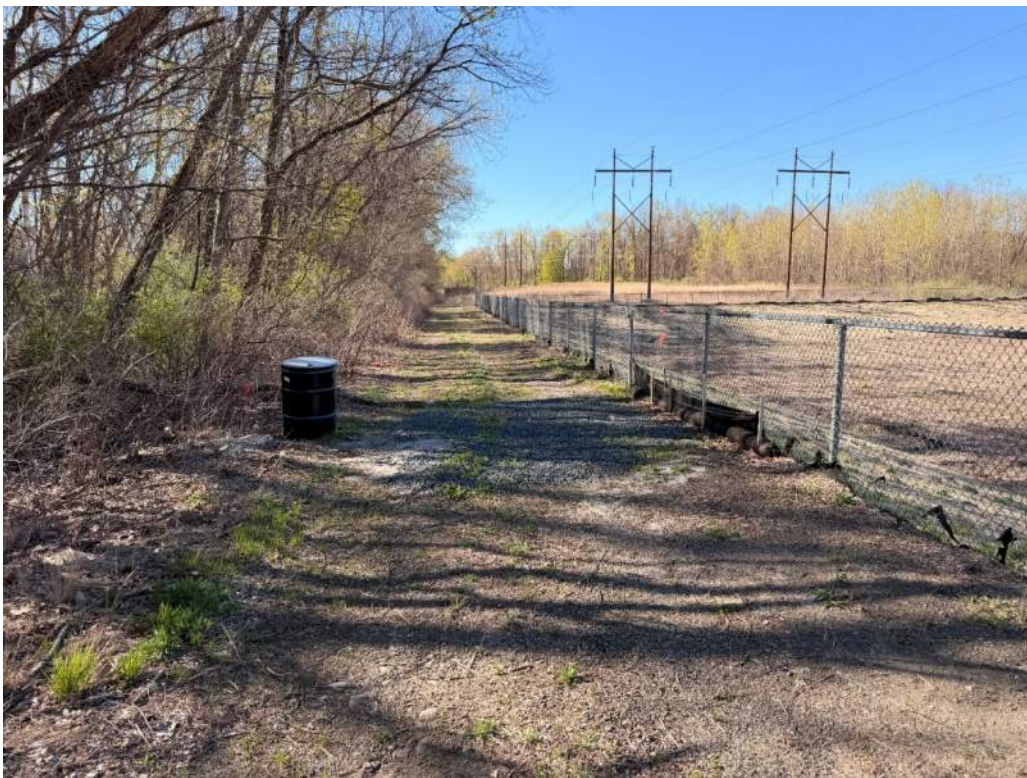
**Photo 8 - Location of recent test boring**

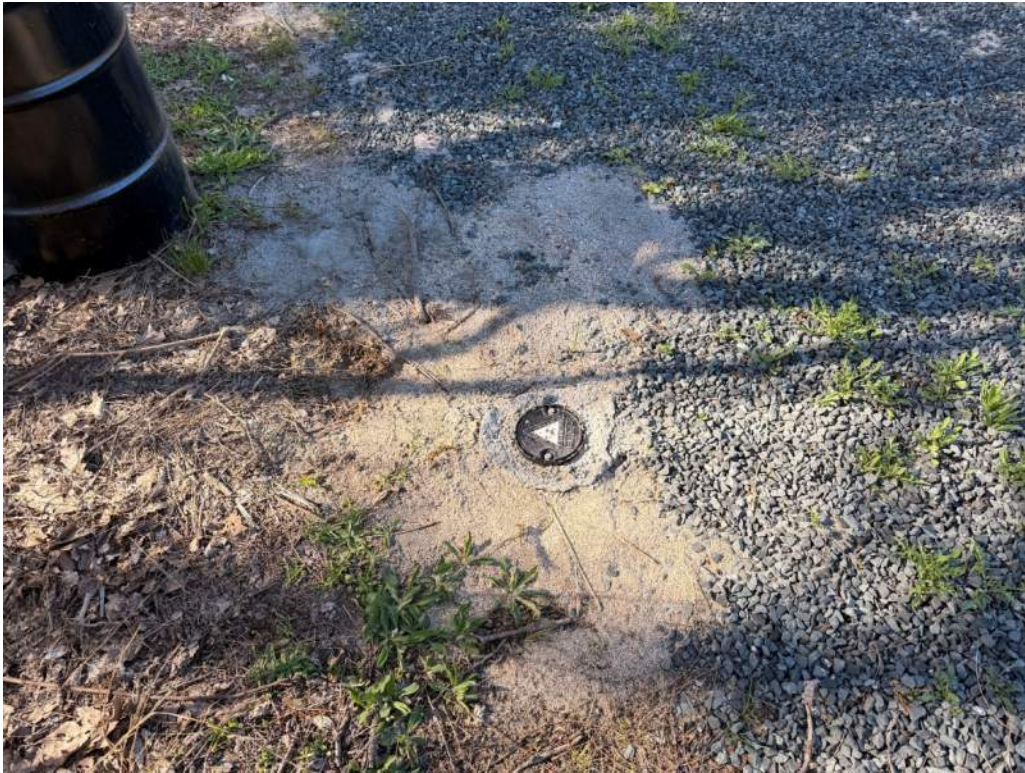
**Photo 9 - Recent test boring**

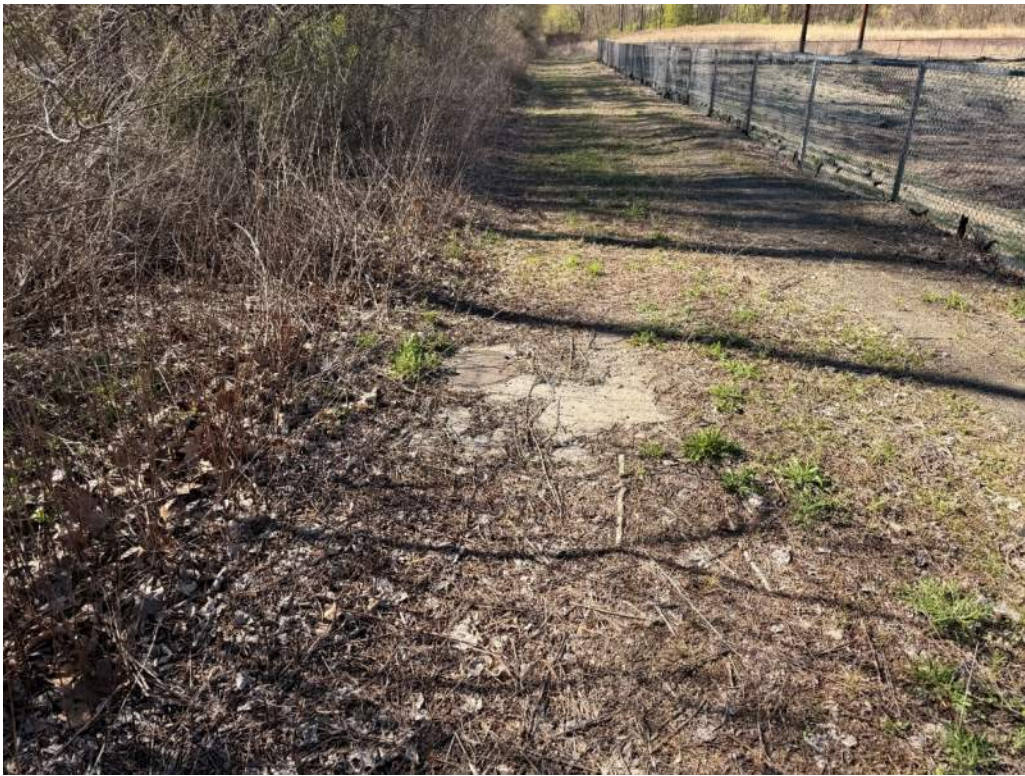
**Photo 10 - Access cover along east embankment crest**

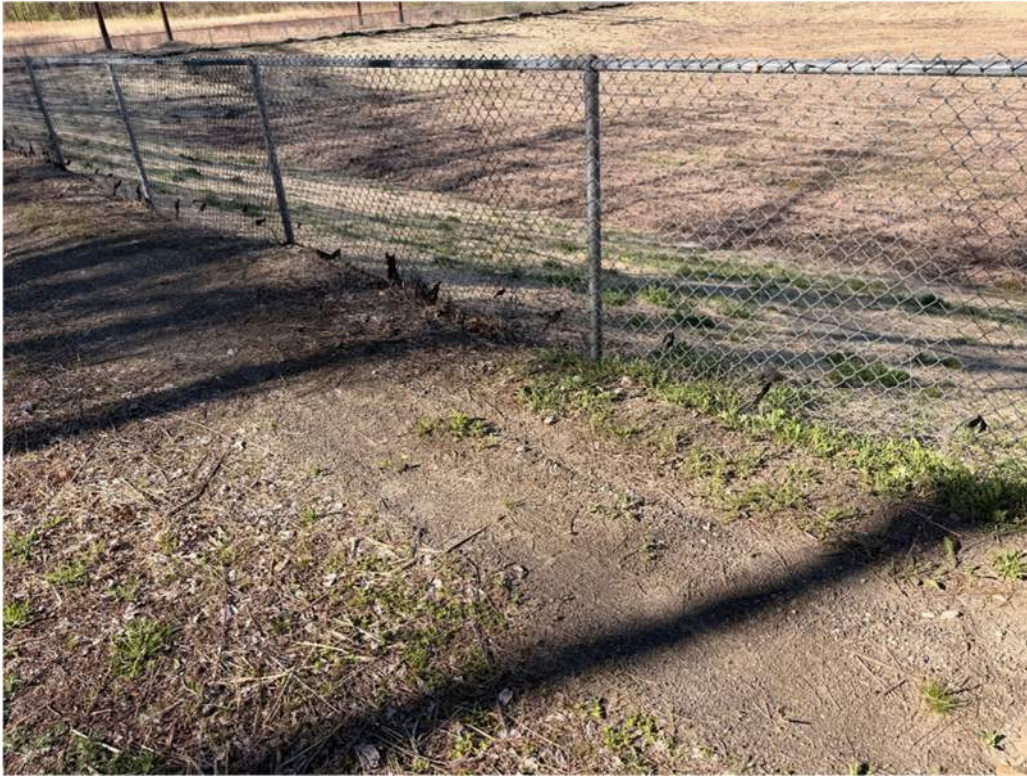
**Photo 11 - Bare area on east embankment crest**

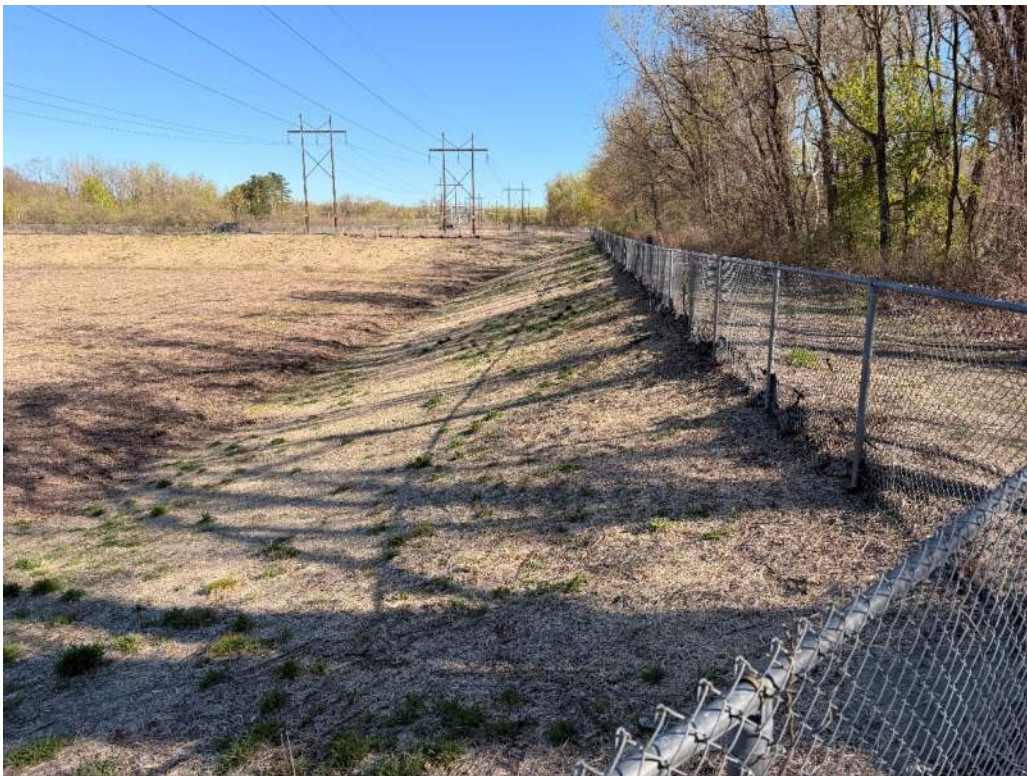
**Photo 12 - East interior slope from south; vegetation remains sparse but area has been recently seeded and mulched**

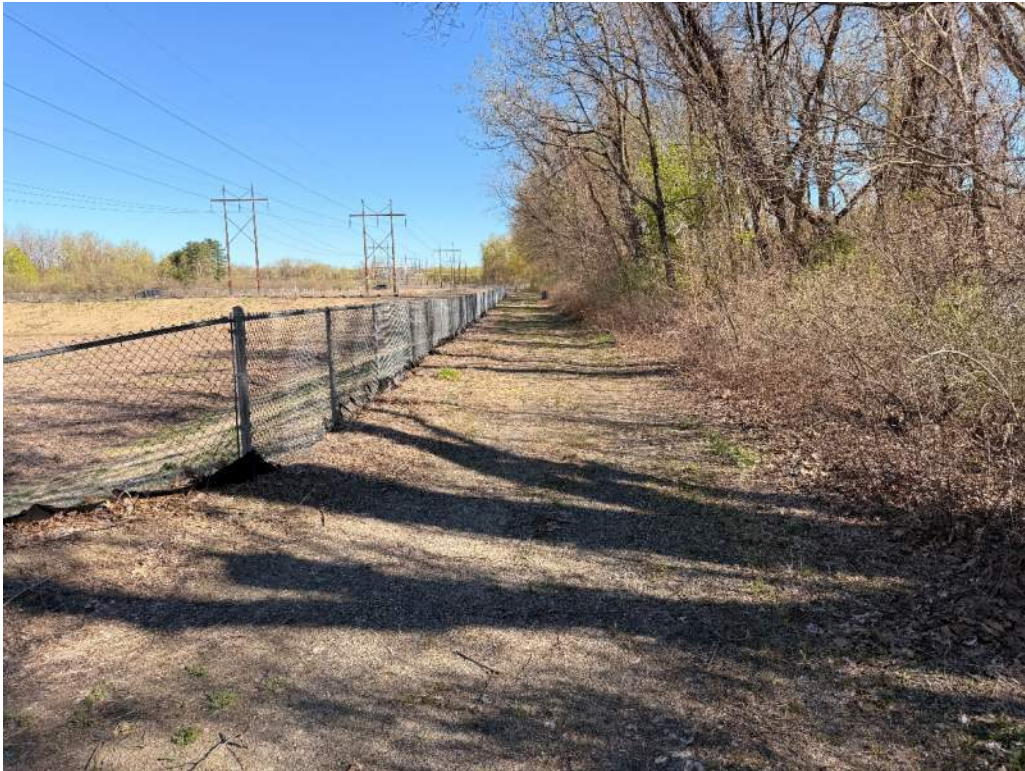
**Photo 13 - East embankment crest from south; note marginal vegetation**

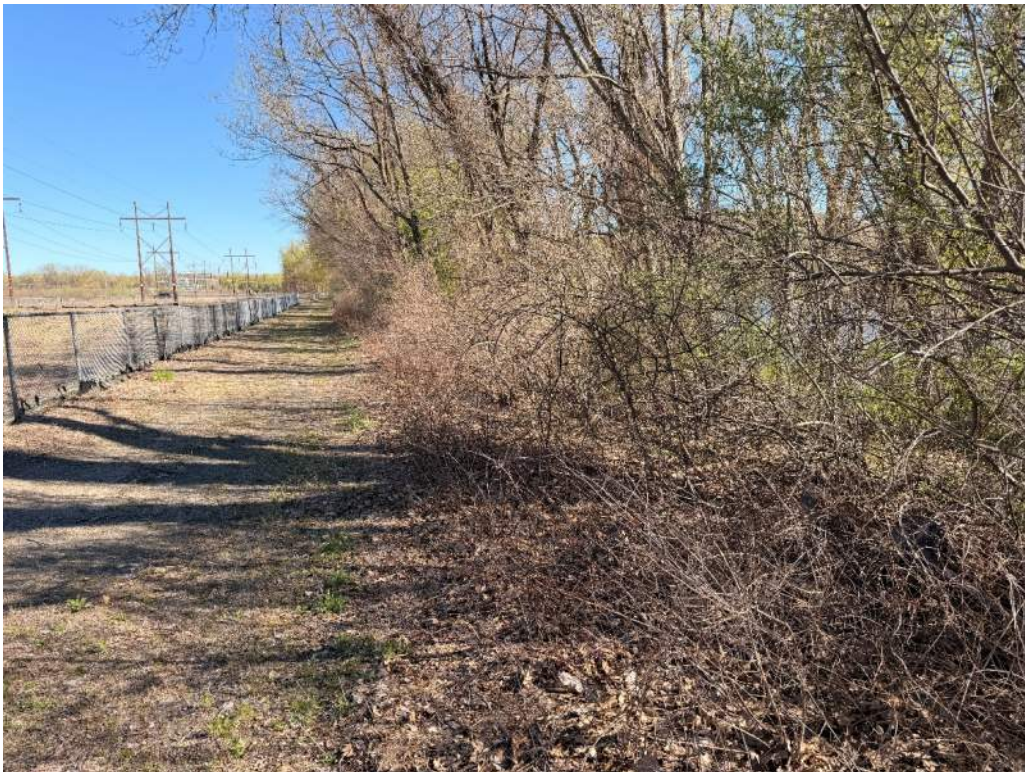
**Photo 14 - East exterior slope from south; note heavy trees and brush**

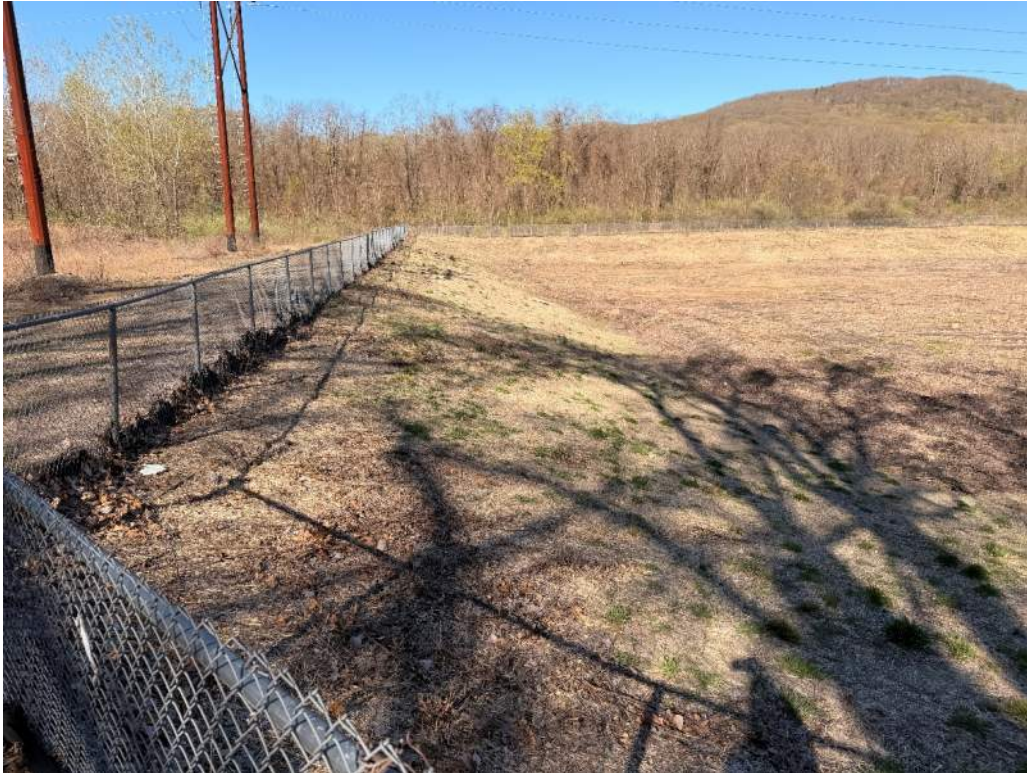
**Photo 15 - South interior slope; vegetation remains sparse but slope has been recently seeded and mulched**

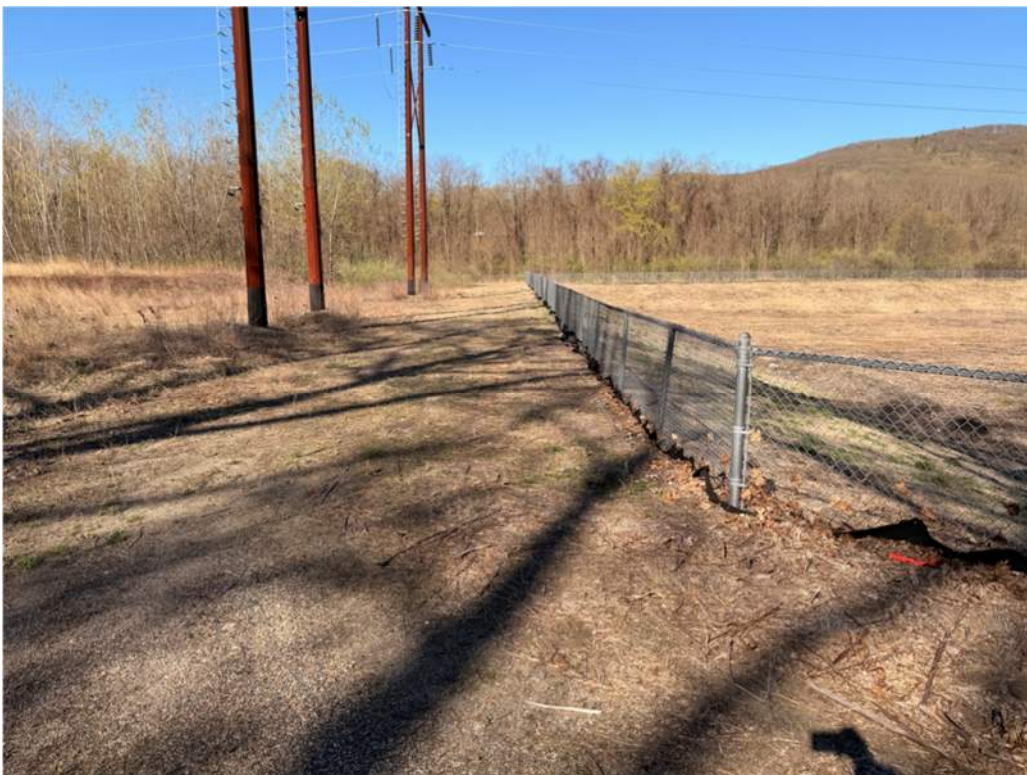
**Photo 16 - South embankment crest; area appeared to have been mulched**

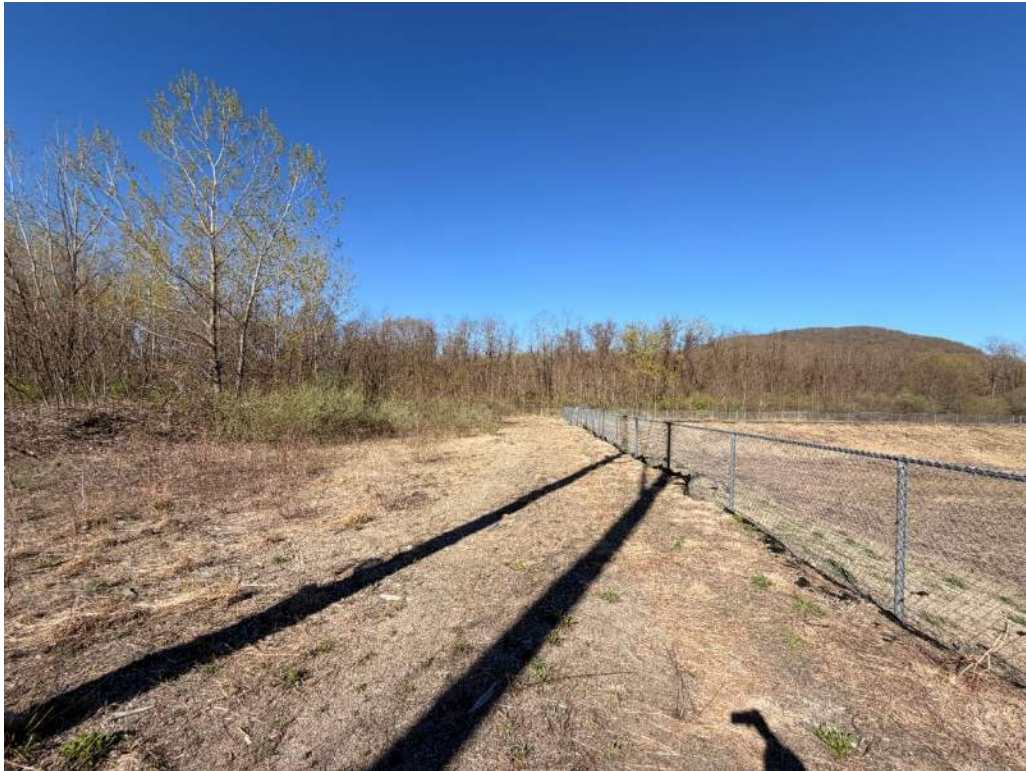
**Photo 17 - South embankment crest; area appeared to have been mulched**

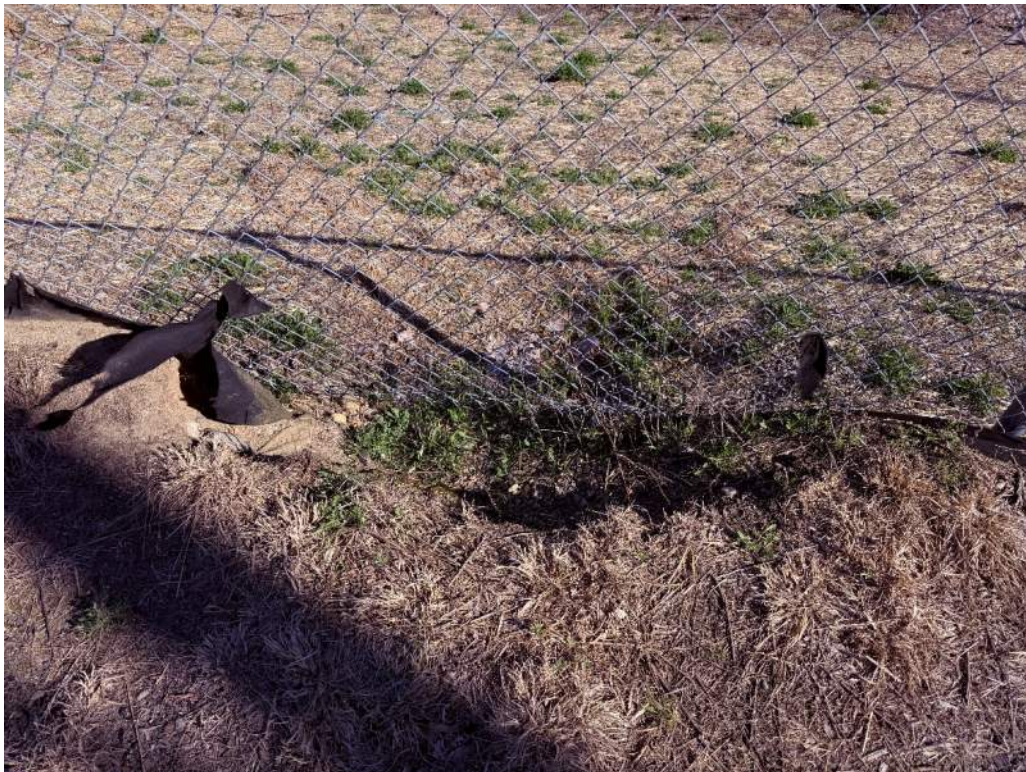
**Photo 18 - Erosion along top of south interior slope**

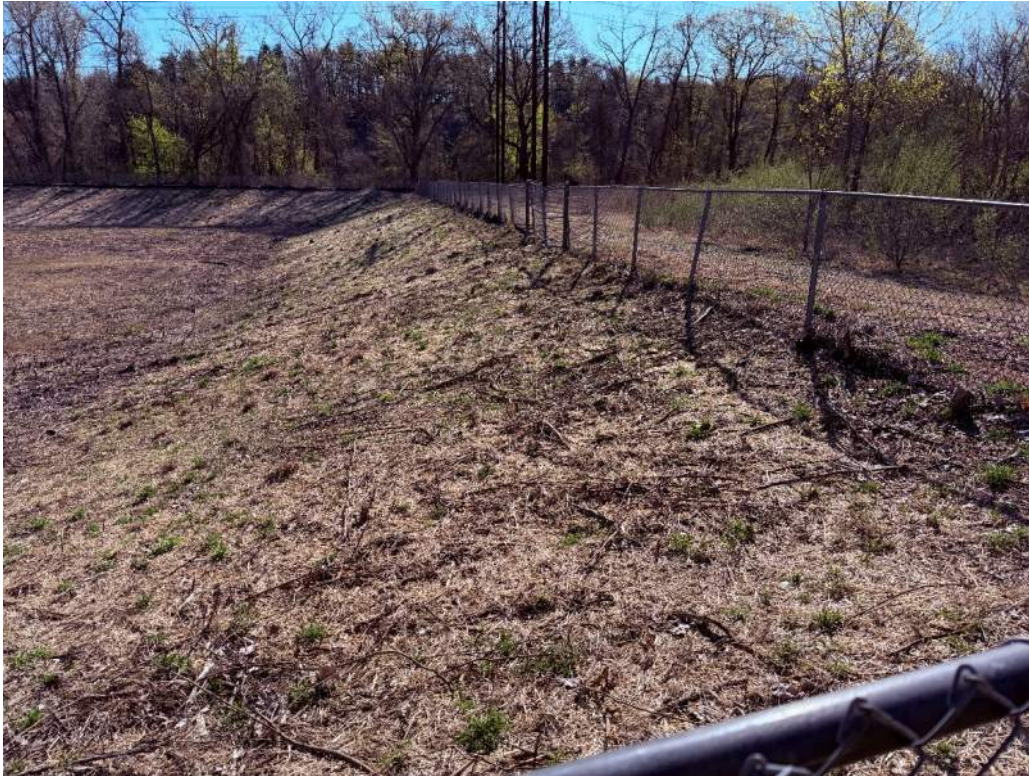
**Photo 19 - South interior slope from west looking east; brush along fence line has been cleared**

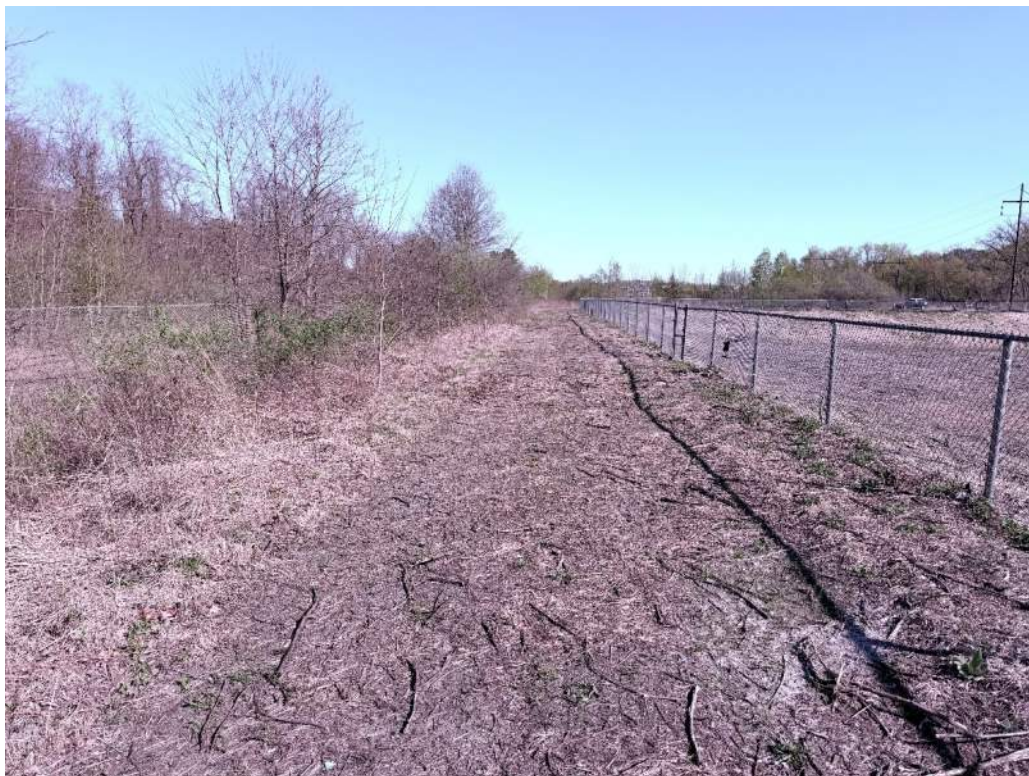
**Photo 20 - West embankment crest looking north; brush along fence line has been cleared**

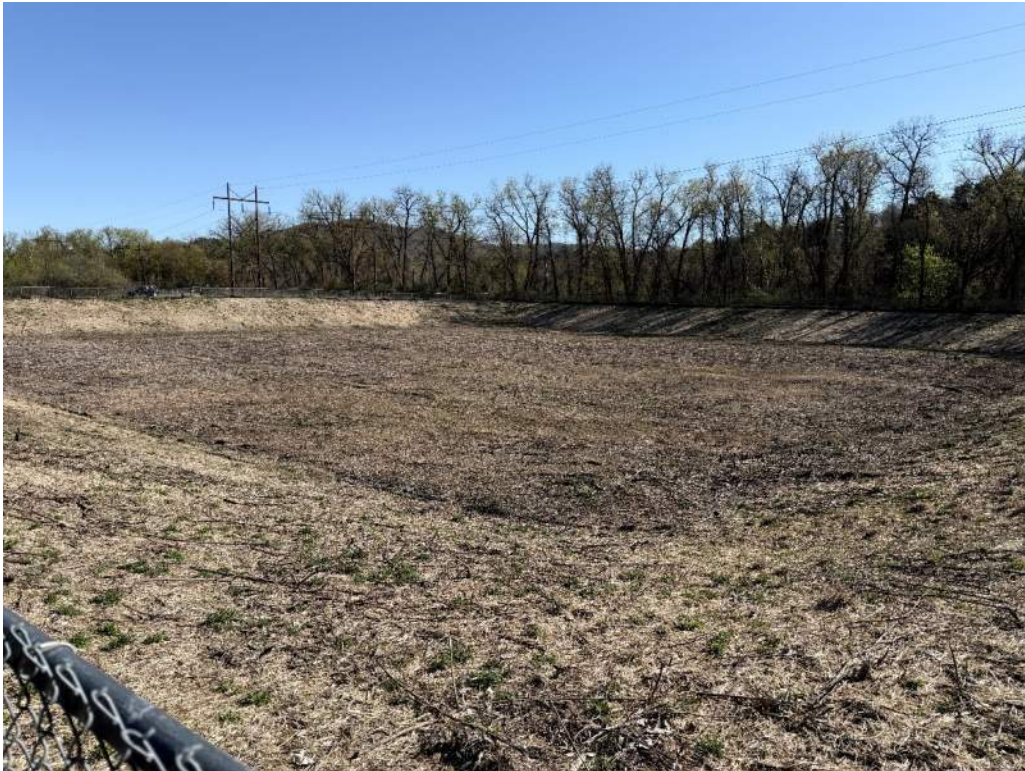
**Photo 21 - Bottom Ash Basin A bottom from southwest corner**

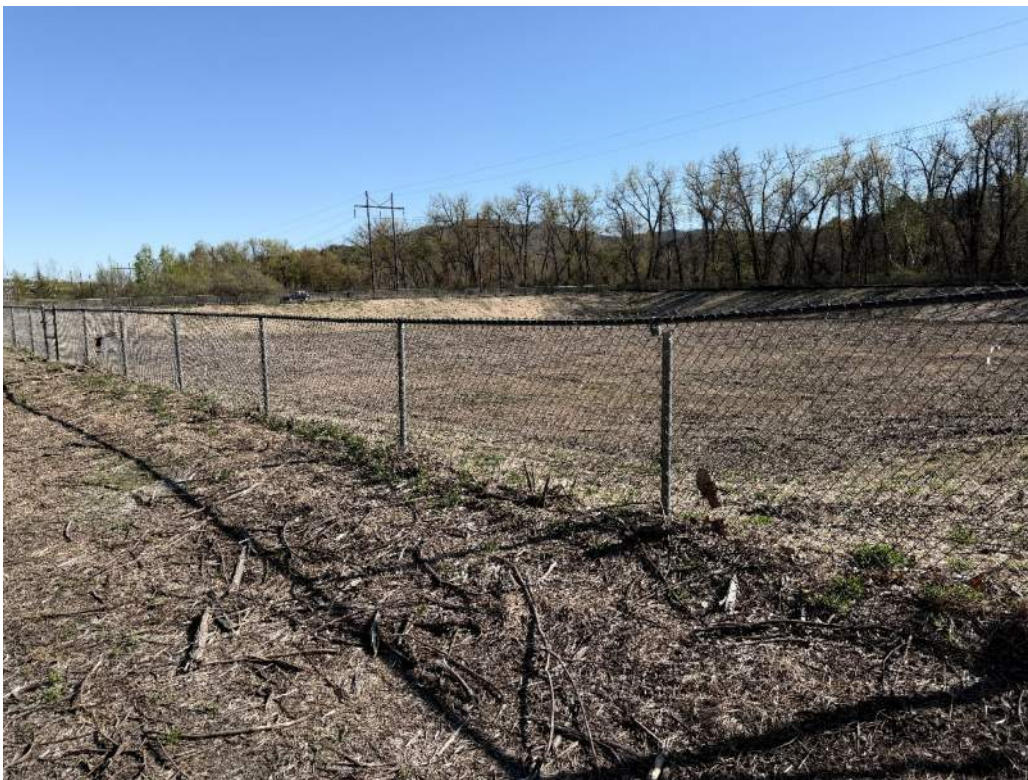
**Photo 22 - Repaired section of chain link fence**

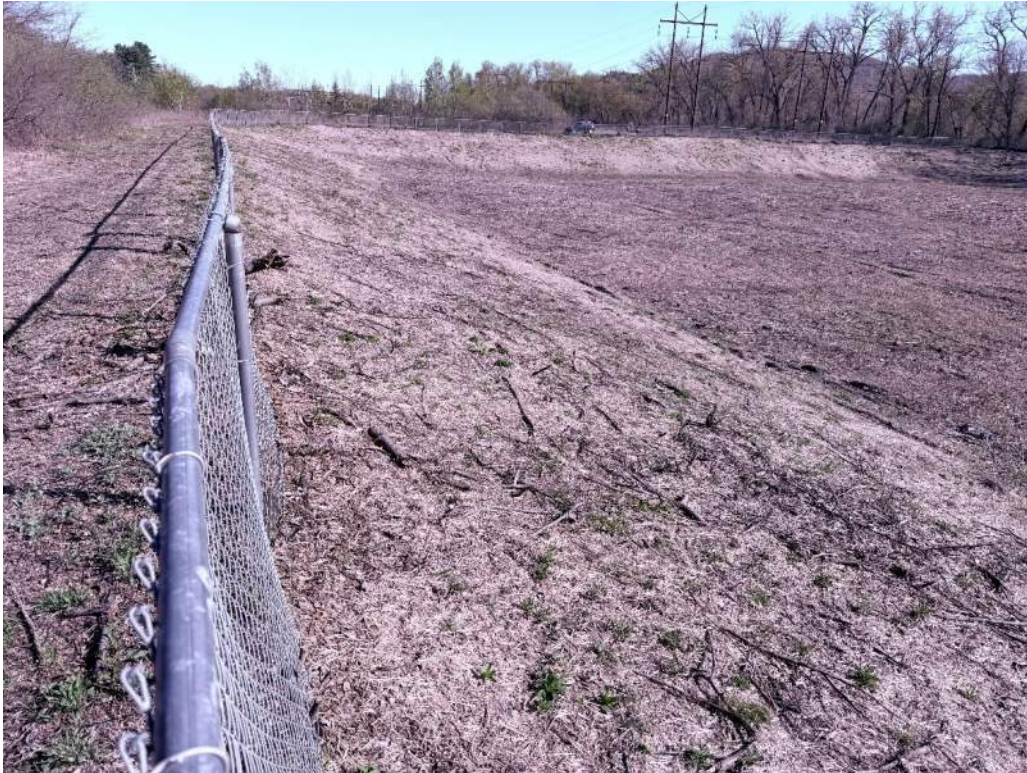
**Photo 23 - West interior slope; vegetation remains sparse but slope has been recently seeded and mulched**

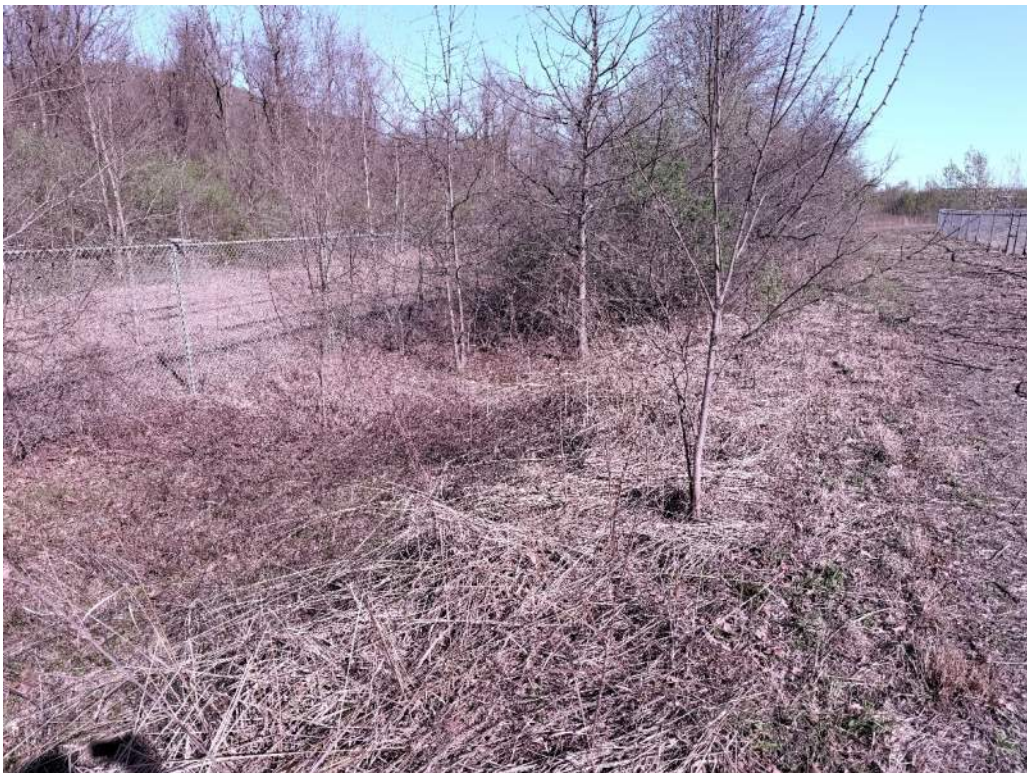
**Photo 24 - West exterior slope; note small trees, brush, and woody vegetation**

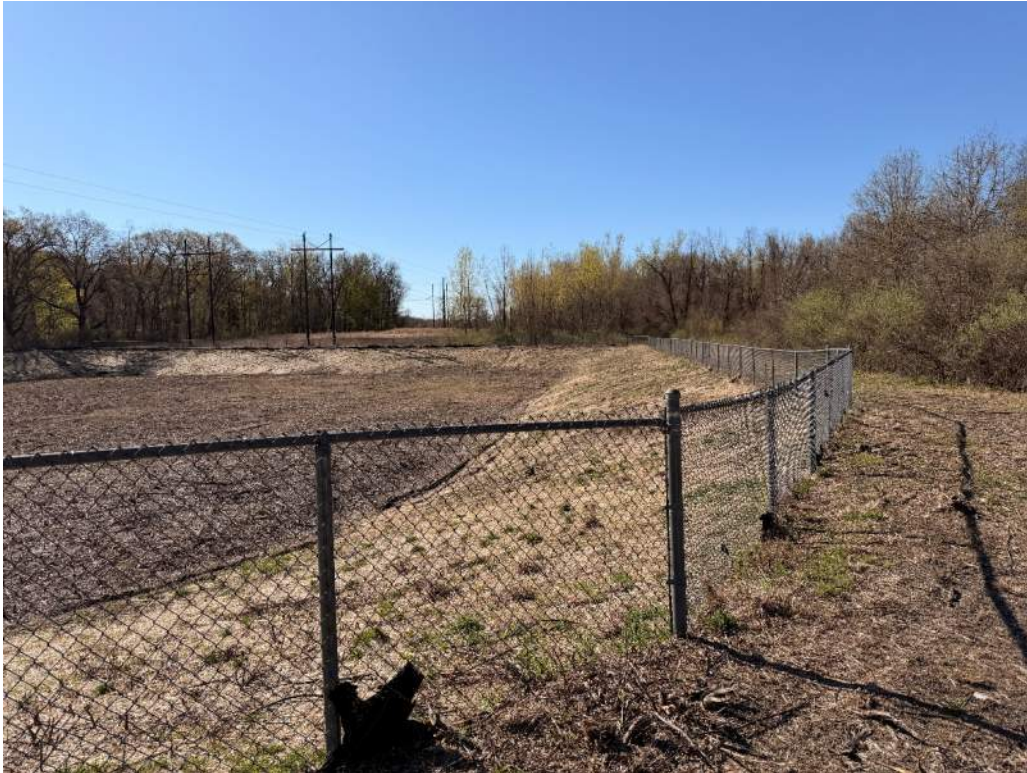
**Photo 25 - West interior slope from north; woody vegetation has been removed**

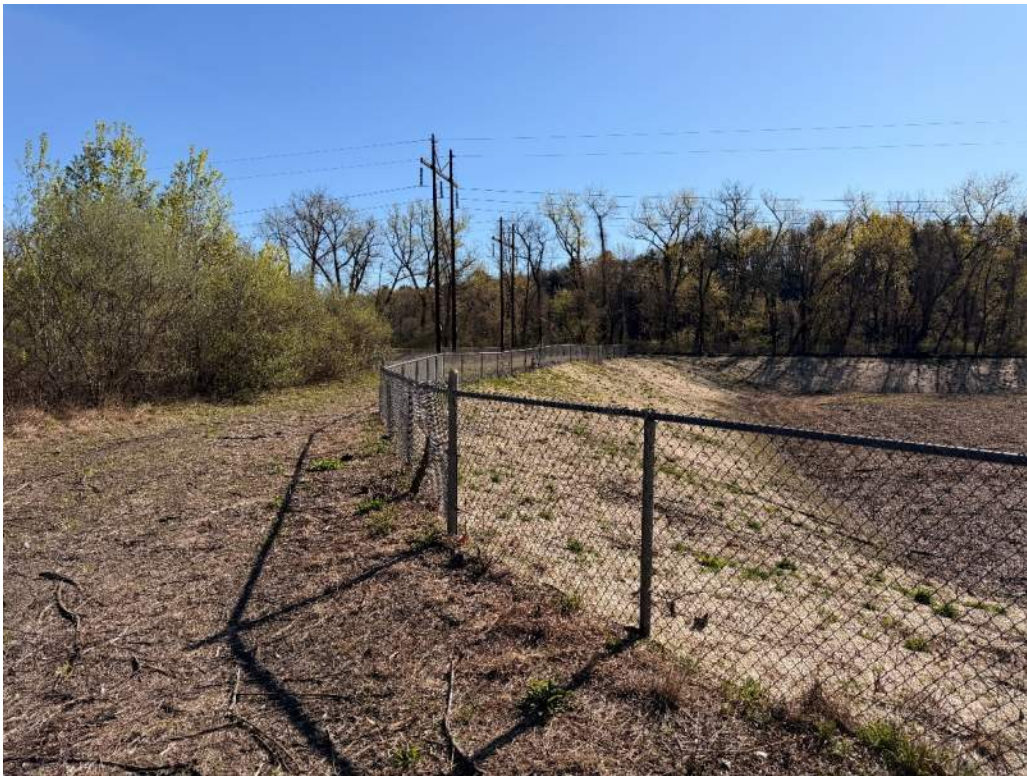
**Photo 26 - South interior slope; woody vegetation has been removed; slope has recently been seeded and mulched**

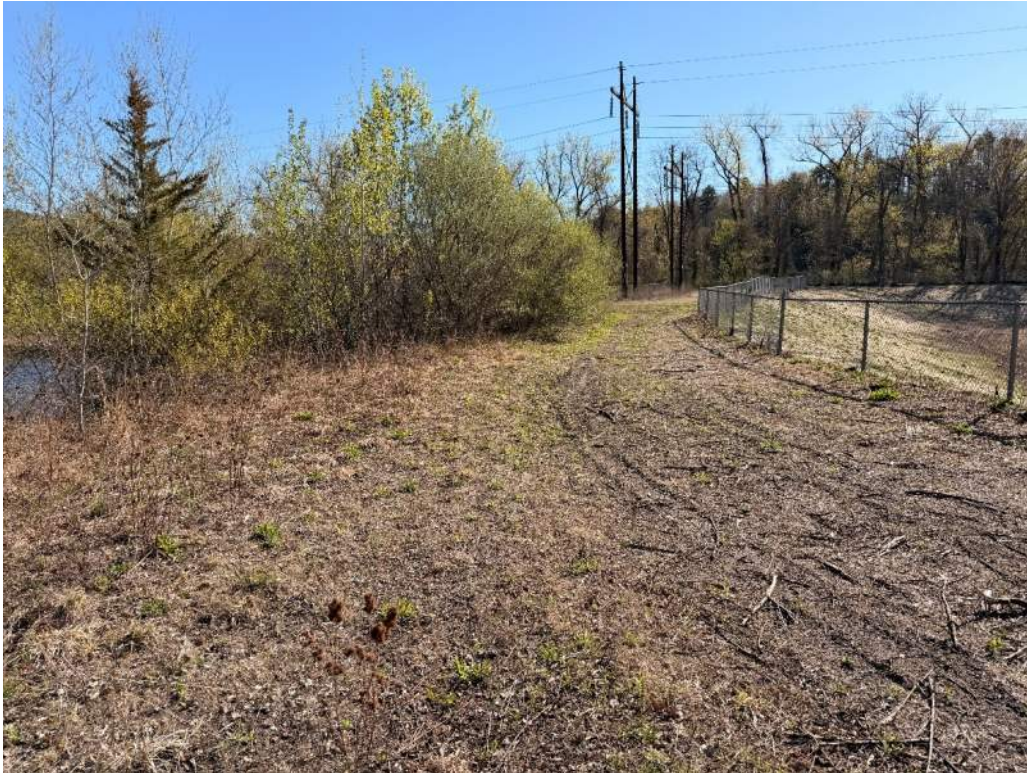
**Photo 27 - South crest; note brush**

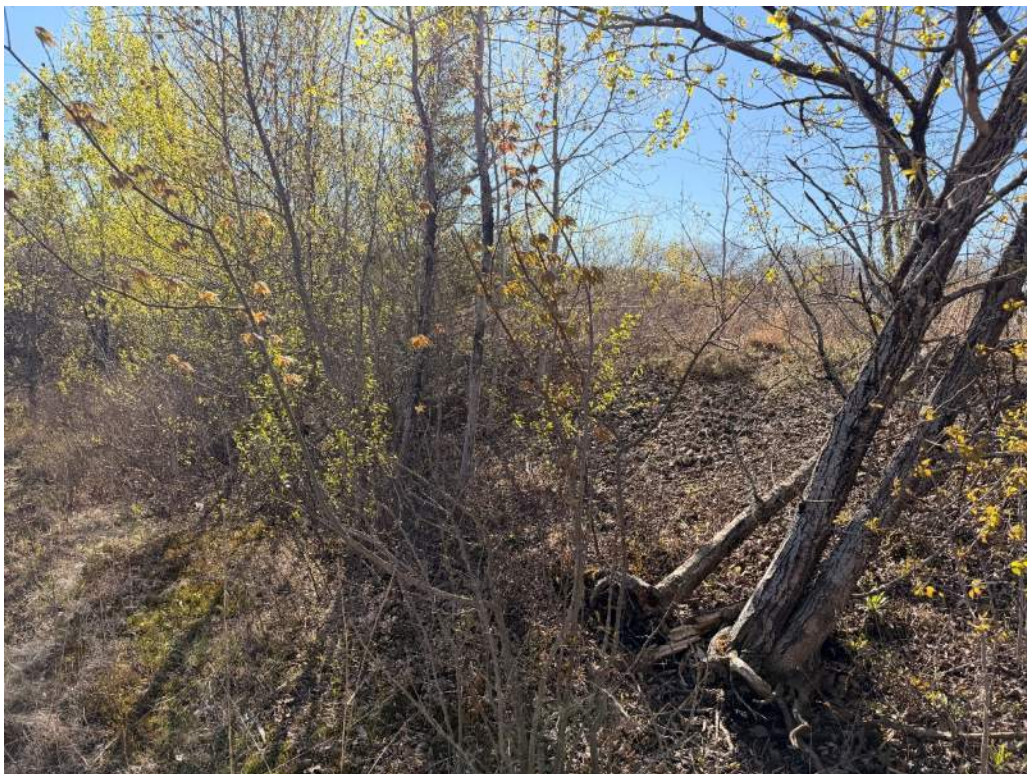
**Photo 28 - North exterior slope along coal pile sump; note woody vegetation**
