Former Mt. Tom Station Power Plant  
200 Northampton Street  
Holyoke, Massachusetts

**Coal Combustion Residuals  
Legacy Surface Impoundments-  
Annual Inspection Report**

**Mt. Tom Generating Company LLC  
Houston, Texas**

August 2026

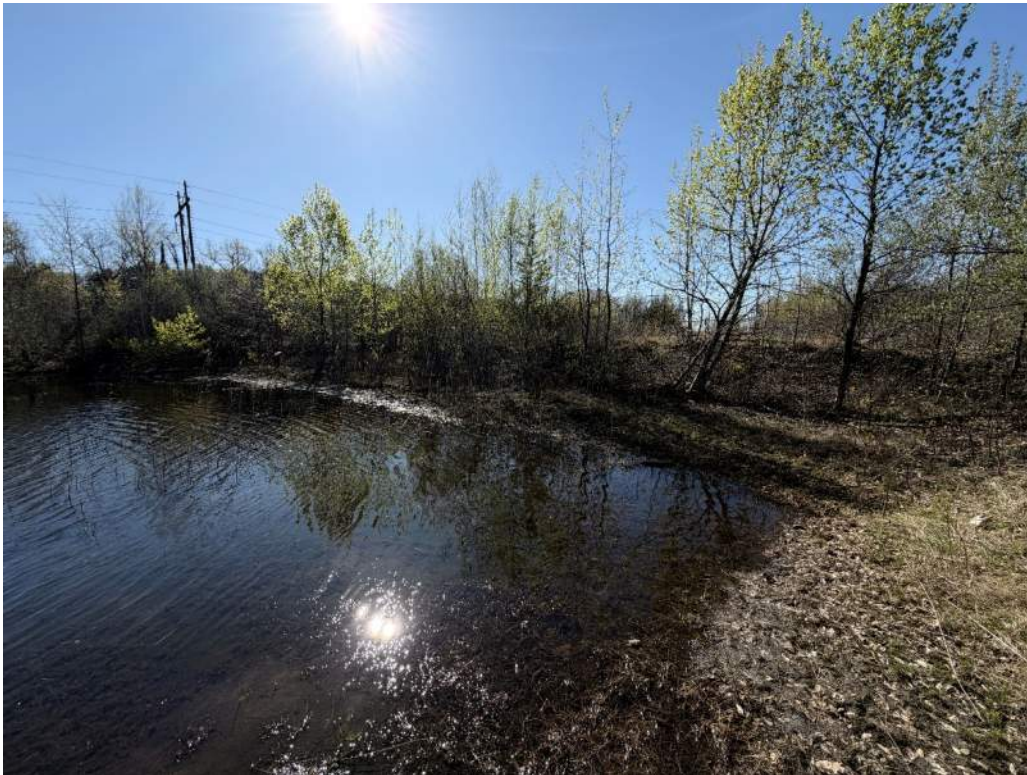
No significant additional structural weaknesses were identified. Visually-evaluated disruptive conditions remain, which include trees growing on the eastern, western, and northwestern exterior slopes. One area of minor erosion was noted along the interior edge of the south embankment crest.

**Photo 29 - North exterior slope along coal pile sump; note woody vegetation**

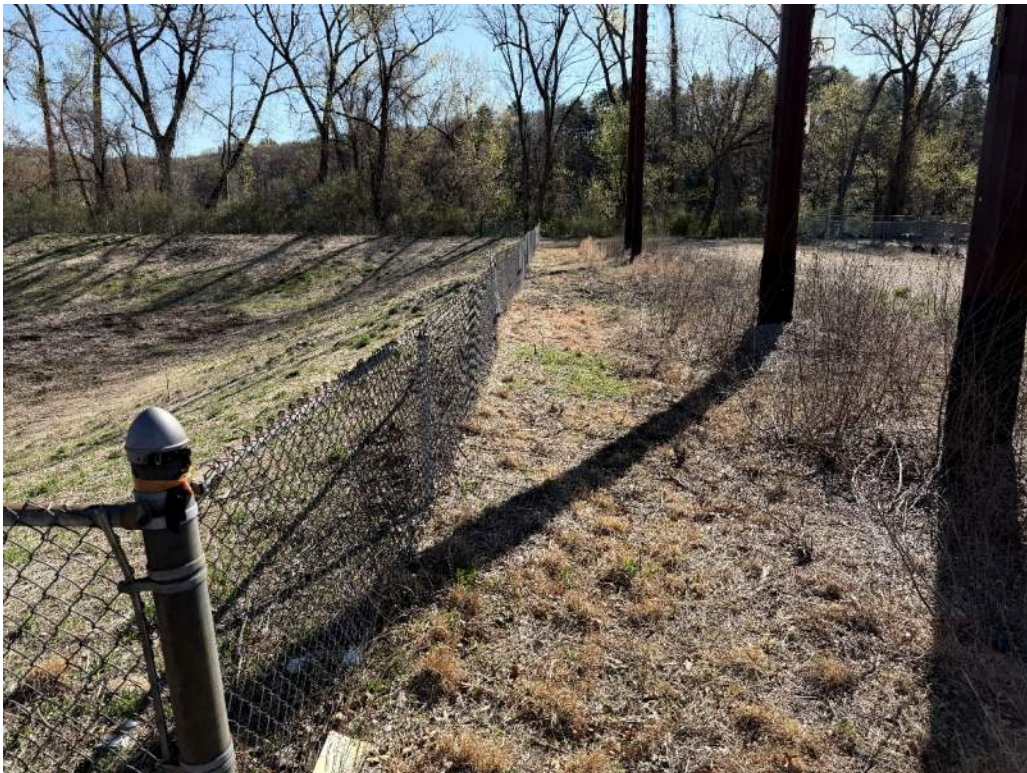
**Photo 30 - North exterior slope along Special Basin**
