Former Mt. Tom Station Power Plant
200 Northampton Street
Holyoke, Massachusetts

**History of Construction -
Bottom Ash Basin A**

**Mt. Tom Generating Company LLC
Houston, Texas**

February 2026

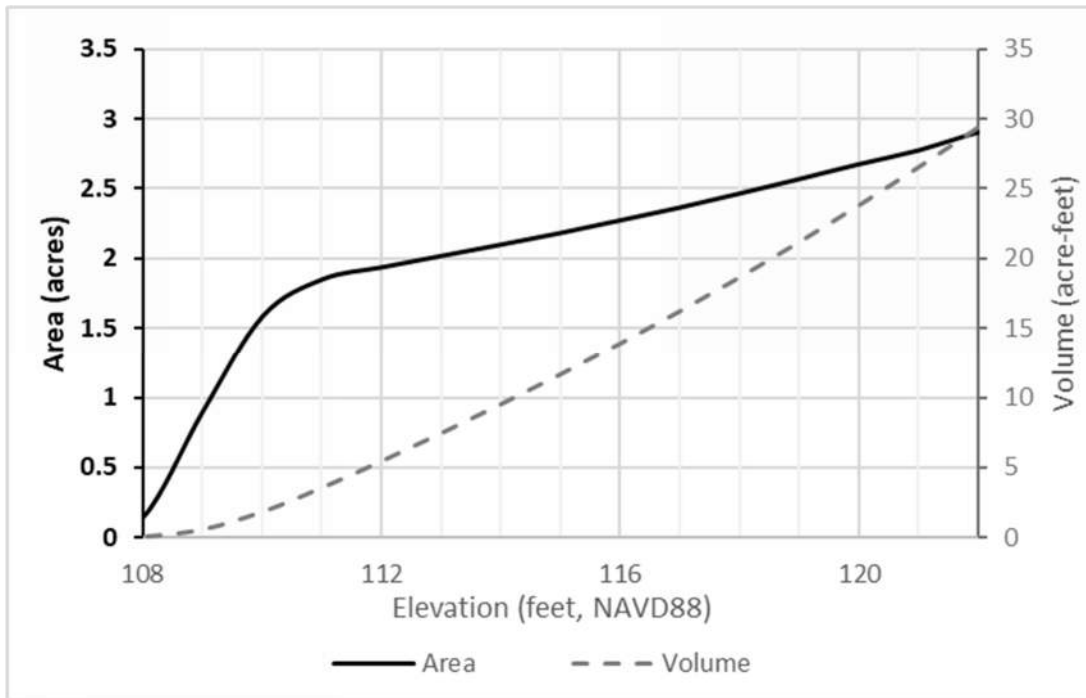
FIGURE 2-1 Area Capacity Curves - Bottom Ash Basin A

Figure 2-1 shows area capacity curves for Bottom Ash Basin A based on USGS LiDAR data for Western Massachusetts with 0.5 meter resolution flown in Spring of 2024¹.

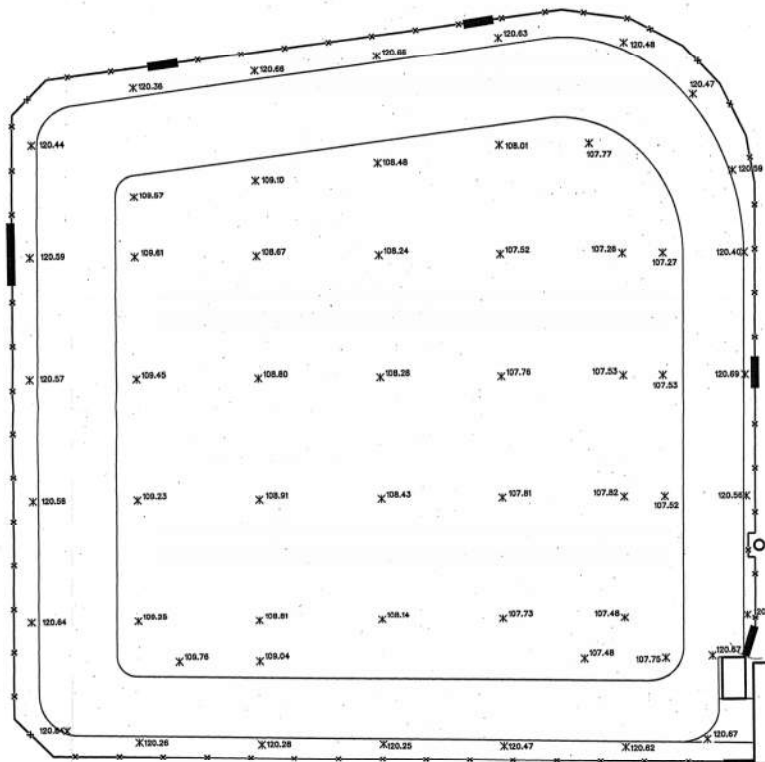
NOTE:
ALL ELEVATIONS WERE TAKEN AT TOP OF LINER.

PLAN OF BOTTOM ASH BASIN "A"
SCALE: NTS

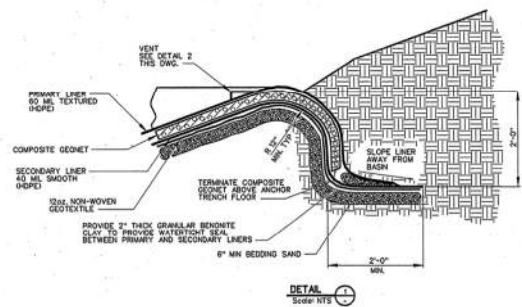
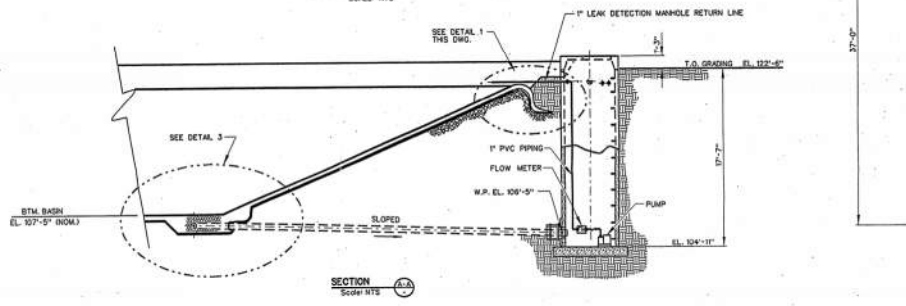
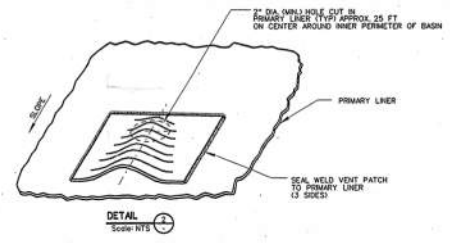
| <p>Northeast Utilities System NORTHEAST GENERATION COMPANY</p> <p>PROJECT: SECTION 10276 TITLE: SECTION 10276-10276 SH 31 LEAK COLLECTION SYSTEM PLAN & SECTION DETAILS</p> <p>DATE: 8/1/14 SCALE: NTS DRAWN BY: [blank] CHECKED BY: [blank]</p> <p>PROJECT NO: 43719-10276 SH 31</p> | | | | |

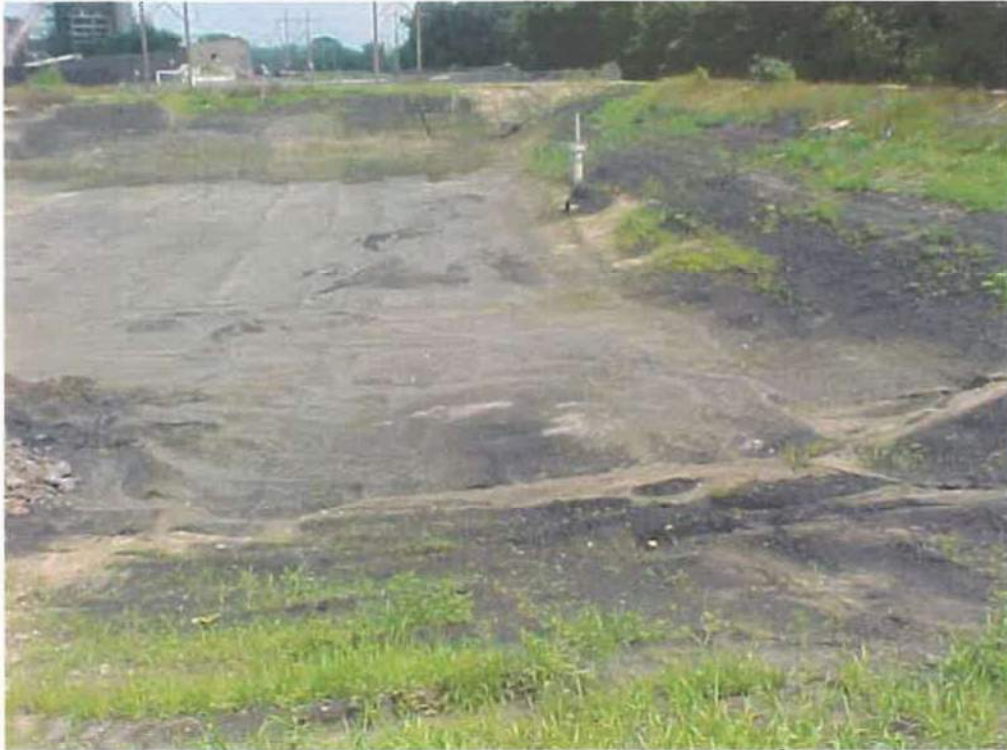
Photo 1 - Drained basin viewing north from the southeast corner

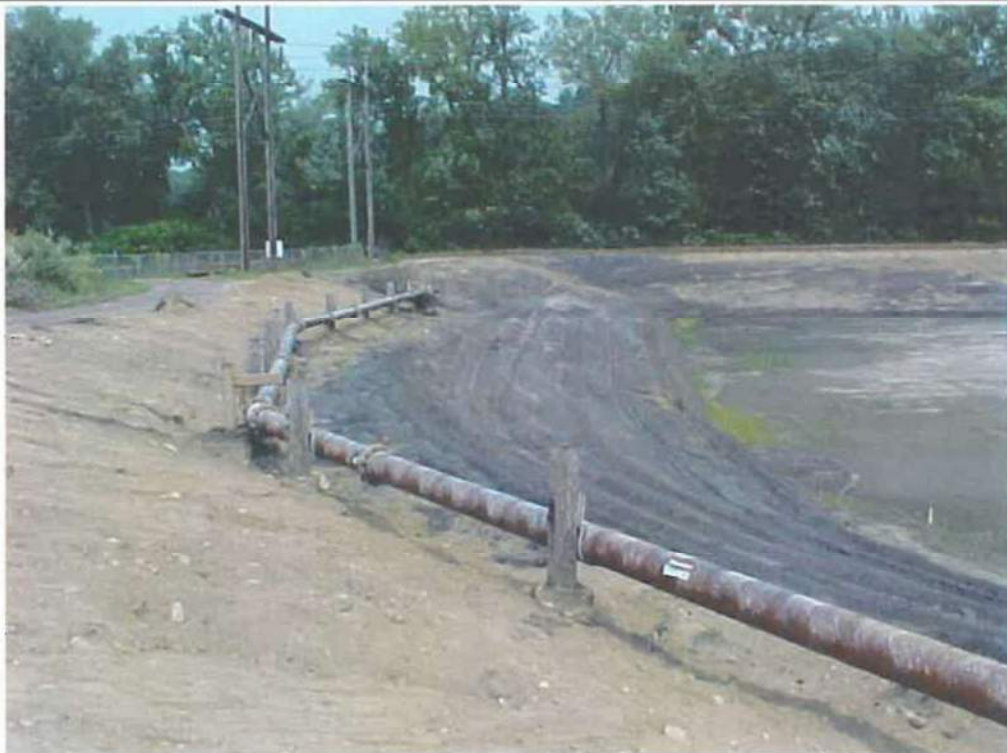
Photo 2 - Pre construction conditions of the north slope

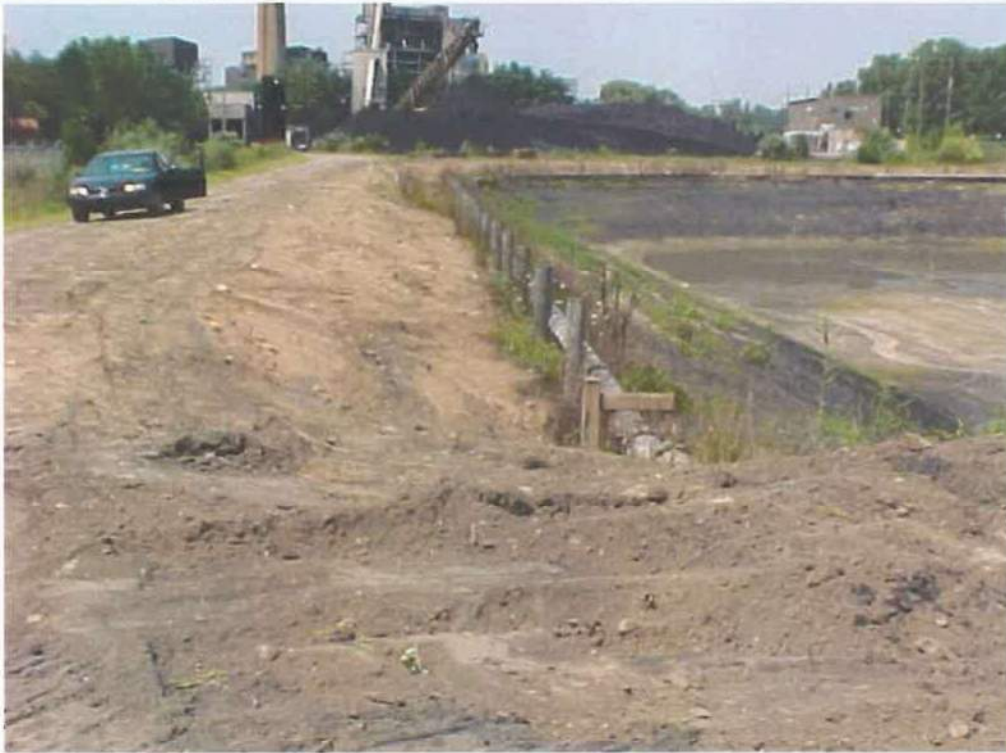
Photo 3 - Pre-construction conditions along the west slope

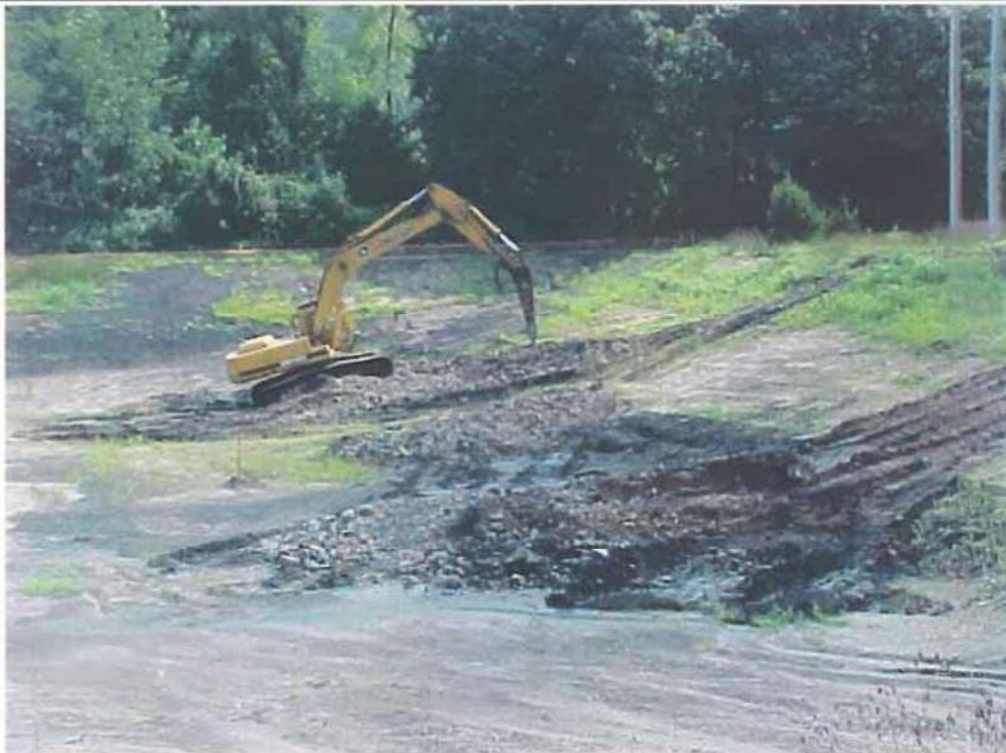
Photo 4 - Site preparation of the south slope

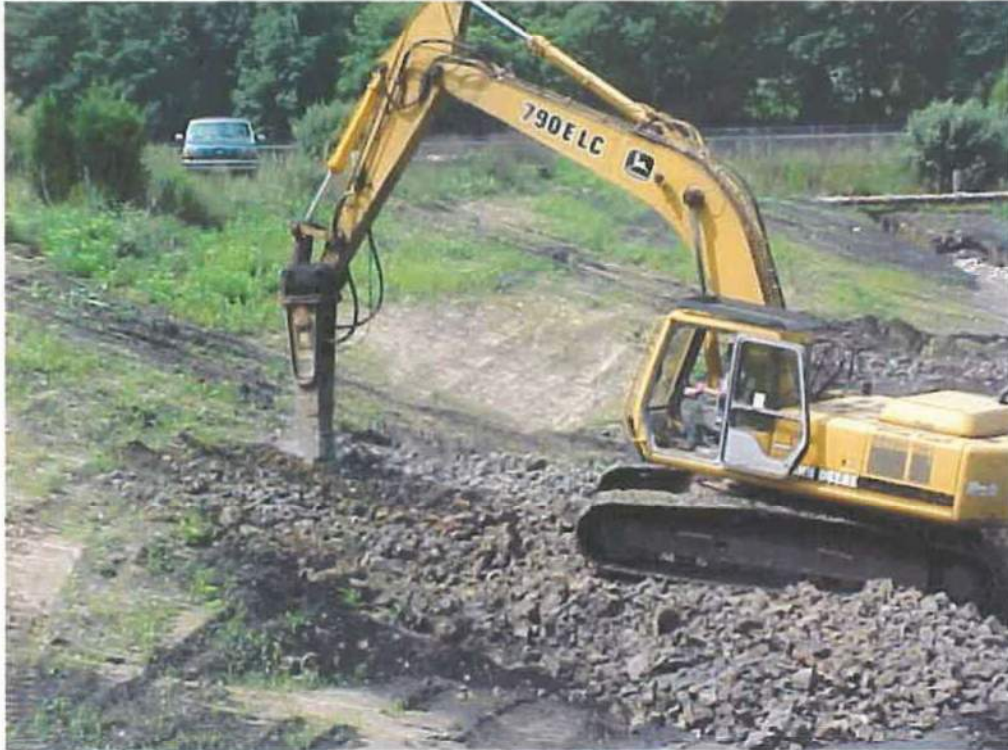
Photo 5 - Ledge removal along the south slope

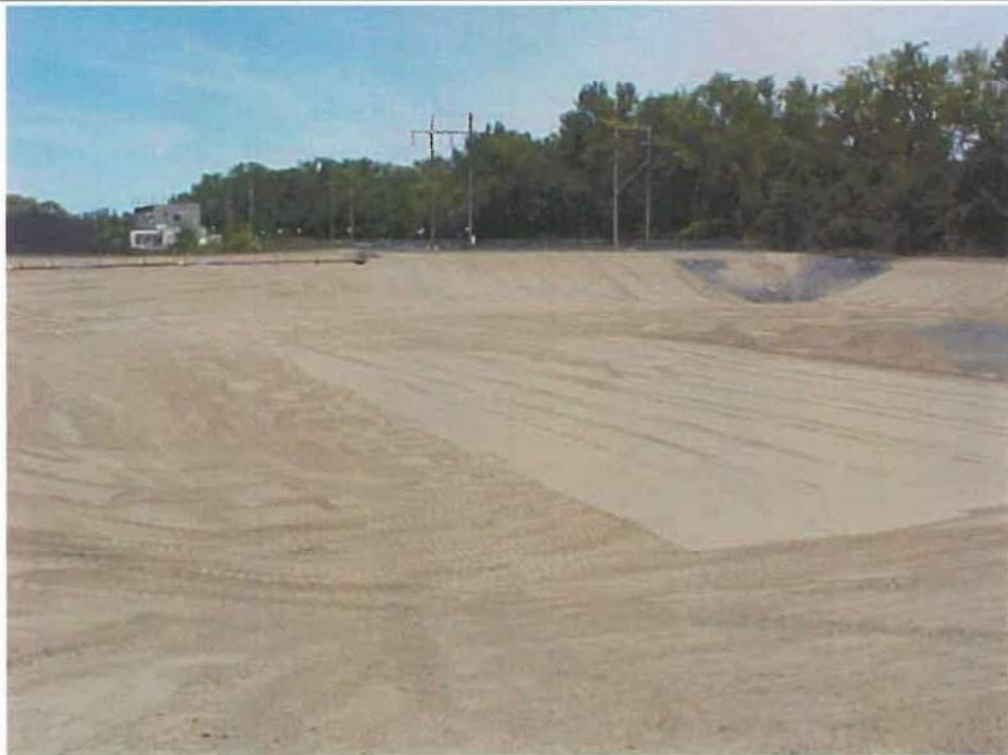
Photo 6 - 6" sand bedding over the entire basin

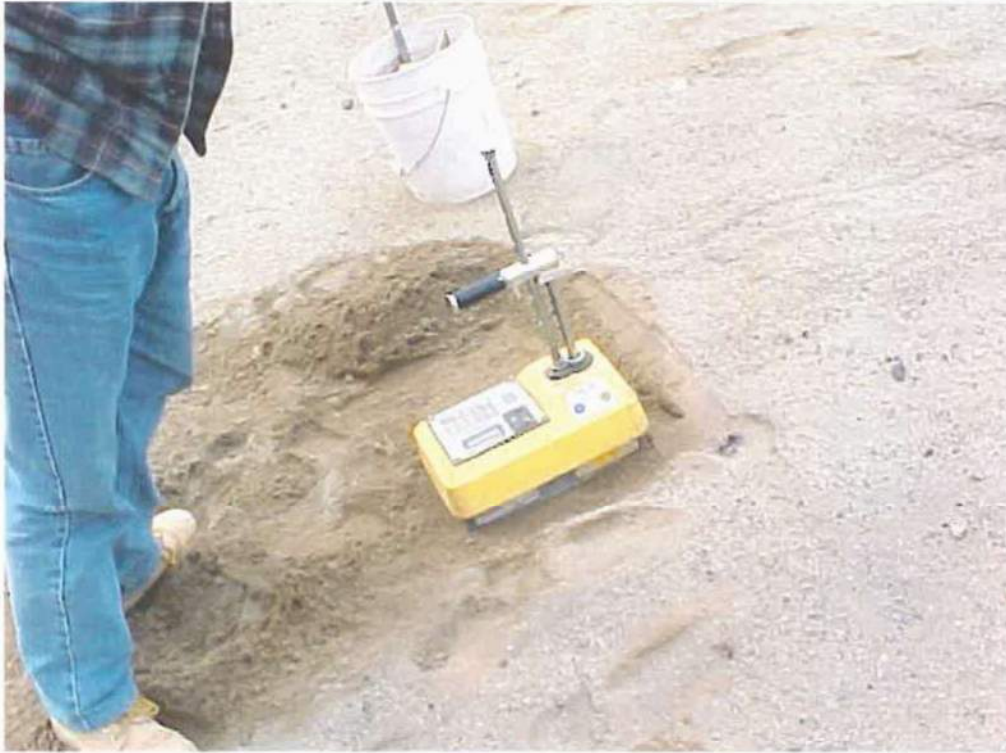
Photo 7 - Compaction testing

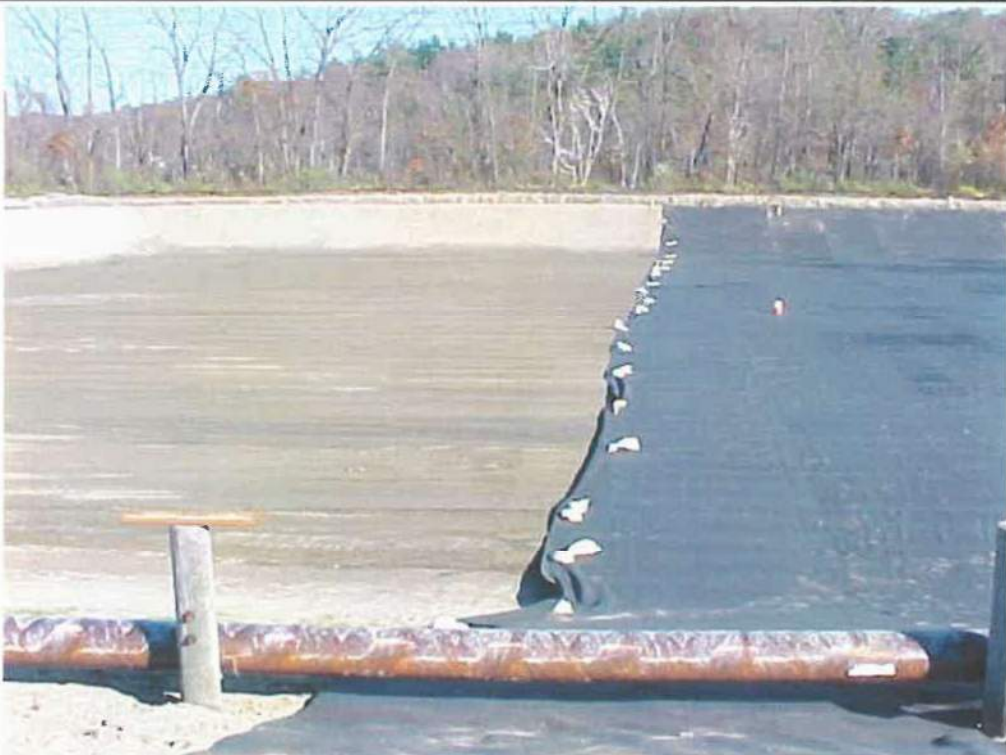
Photo 8 - Deployment of non-woven geotextile fabric, viewing from the west to the east

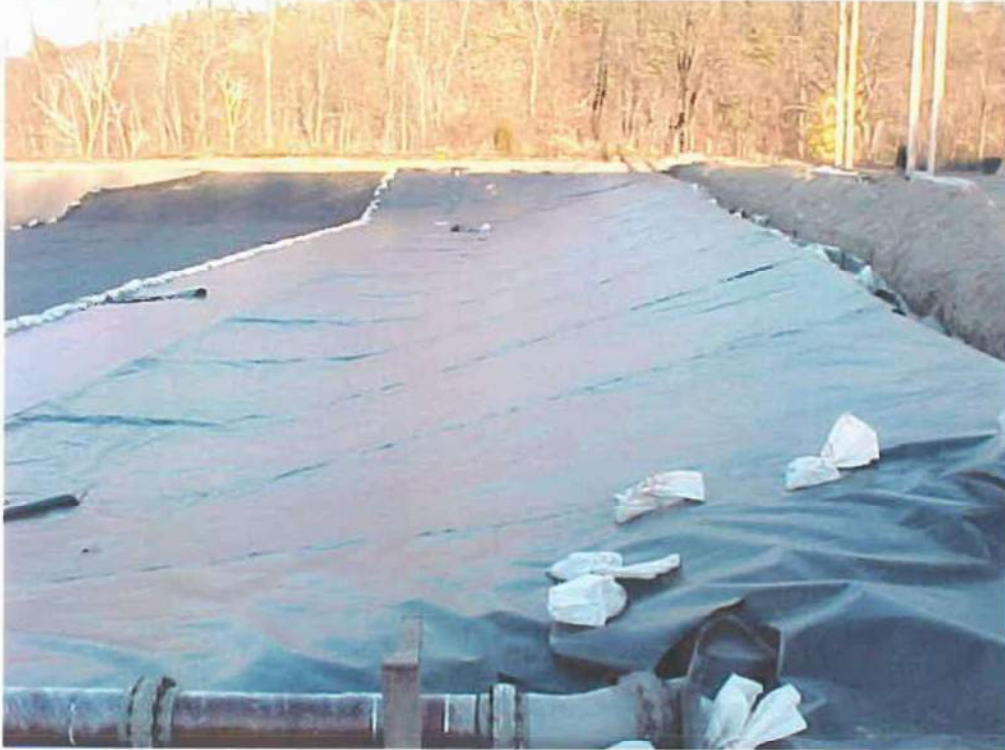
Photo 9 - 40 Mil HDPE liner deployed and seamed along the south slope

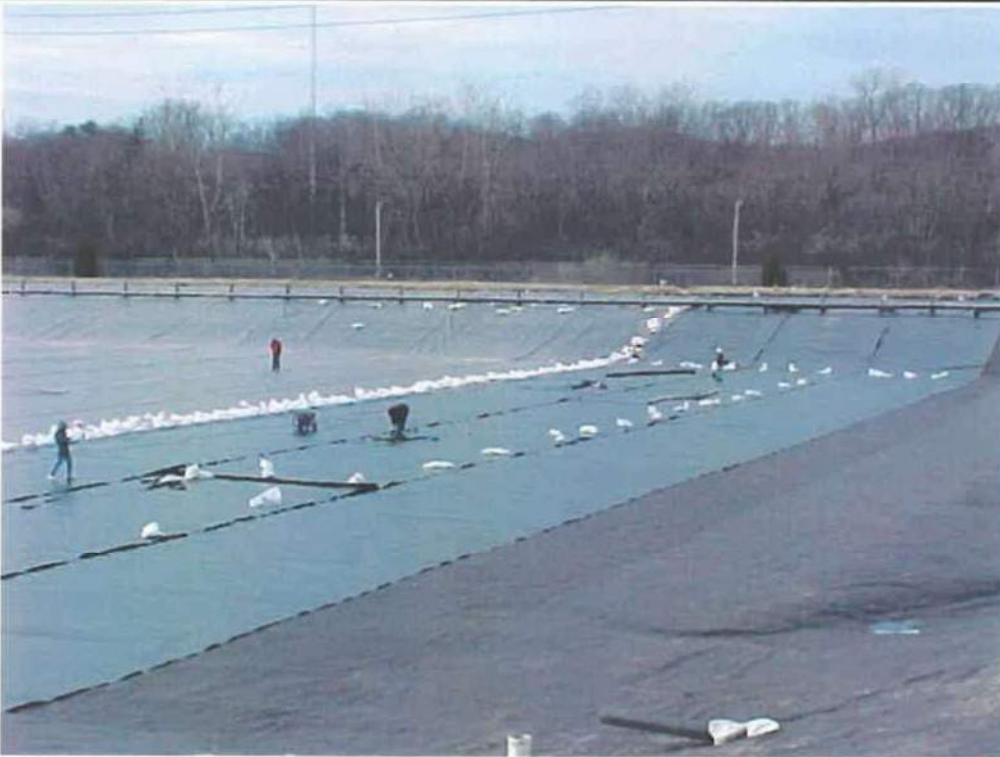
Photo 10 - Deployed 40 Mil HDPE liner viewing from the northeast corner looking back to the west

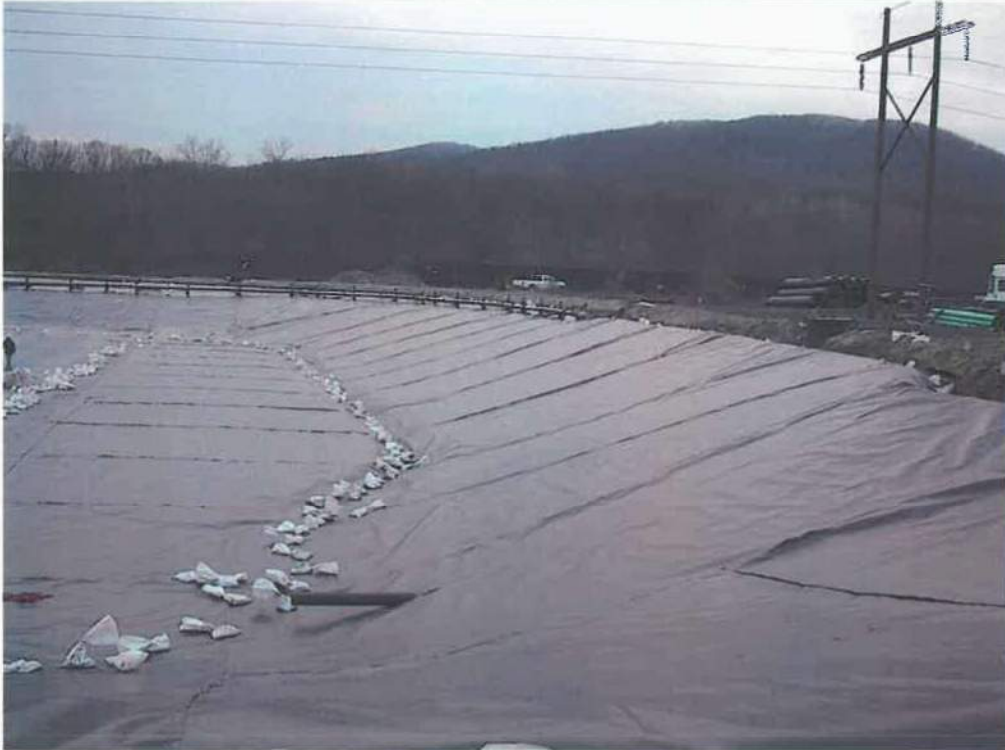
Photo 11 - Deployed and seamed 40 Mil HDPE liner along the north slope

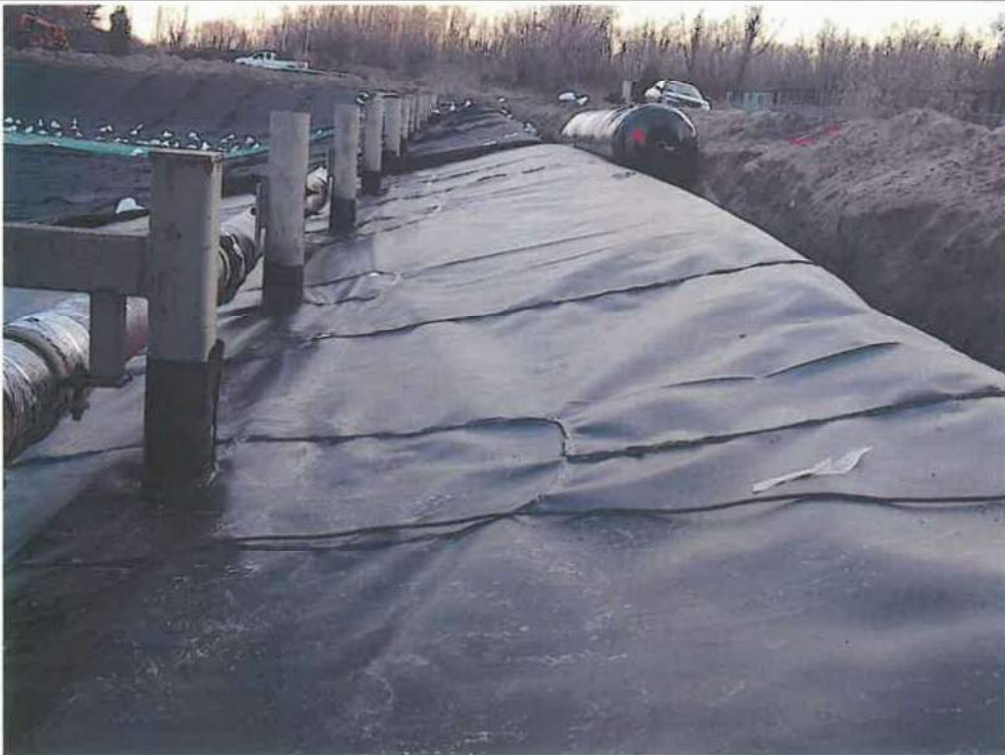
Photo 12 - Typical 40 Mil boots along the top of the west slope

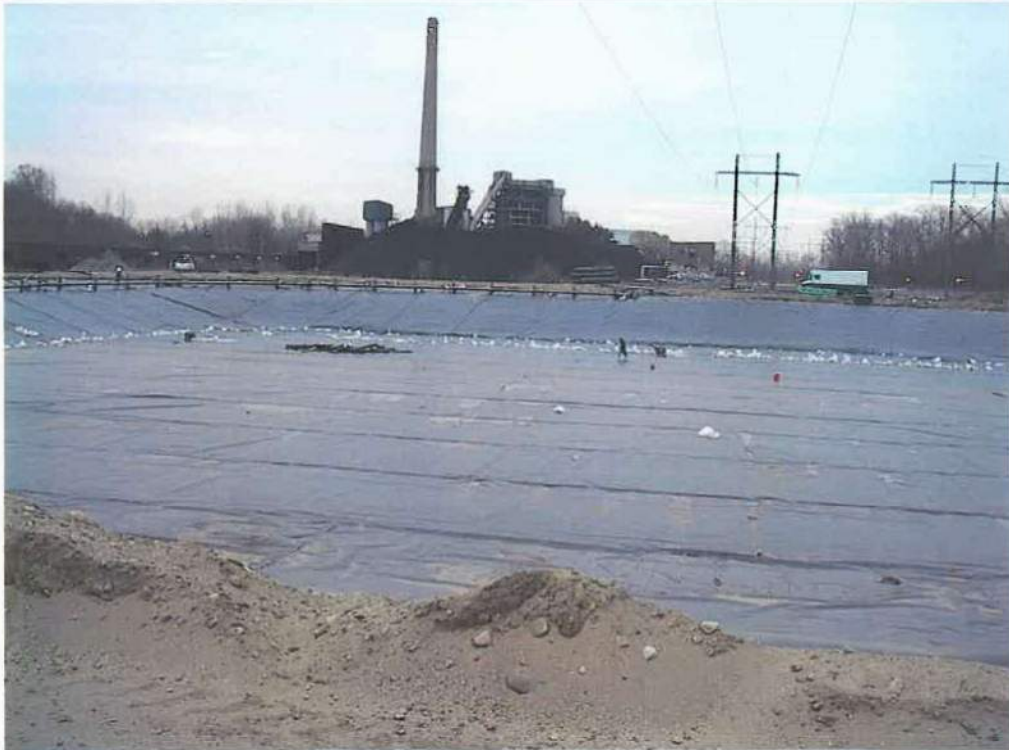
Photo 13 - Completed 40 Mil HDPE liner viewing from the south to the north

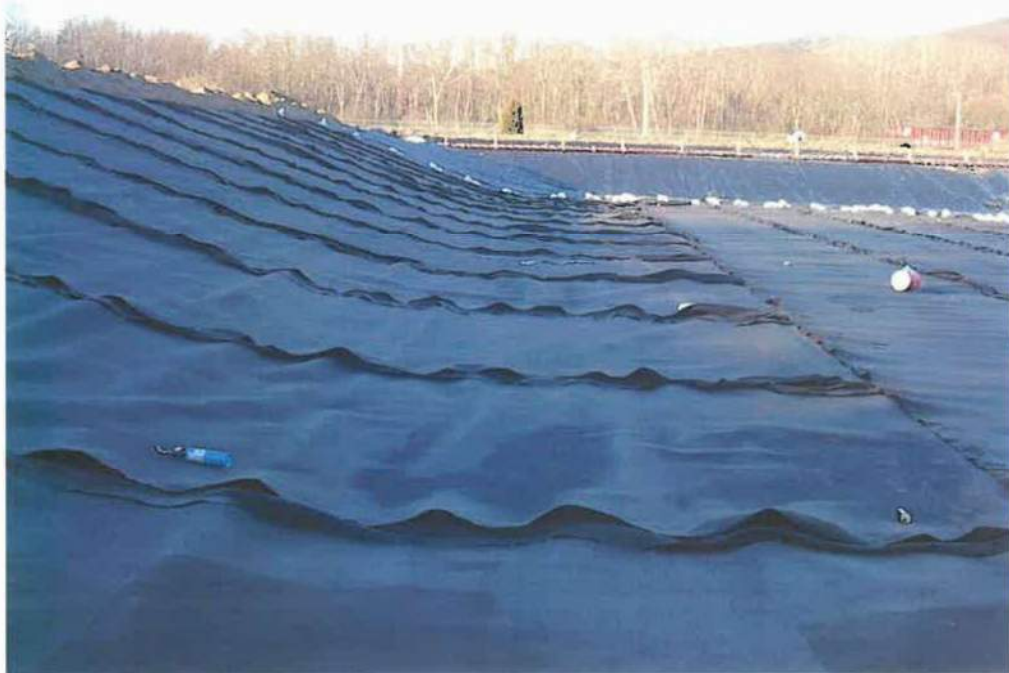
Photo 14 - Deployment of geocomposite drainage layer along the south slope

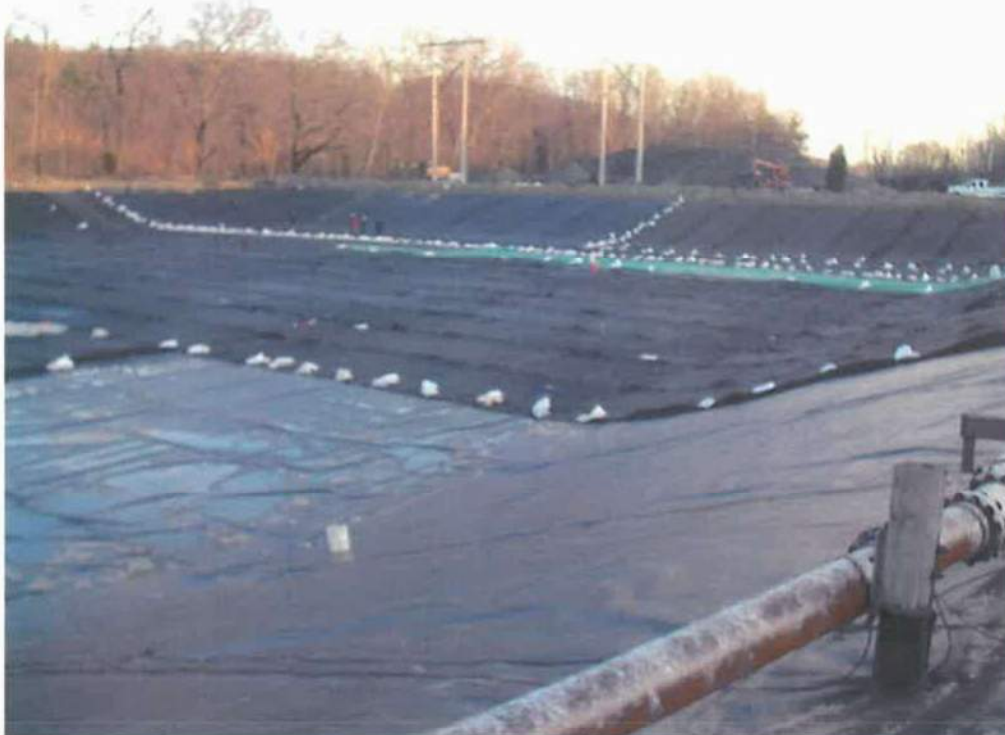
Photo 15 - Deployed geocomposite drainage layer viewing from the west back to the southeast

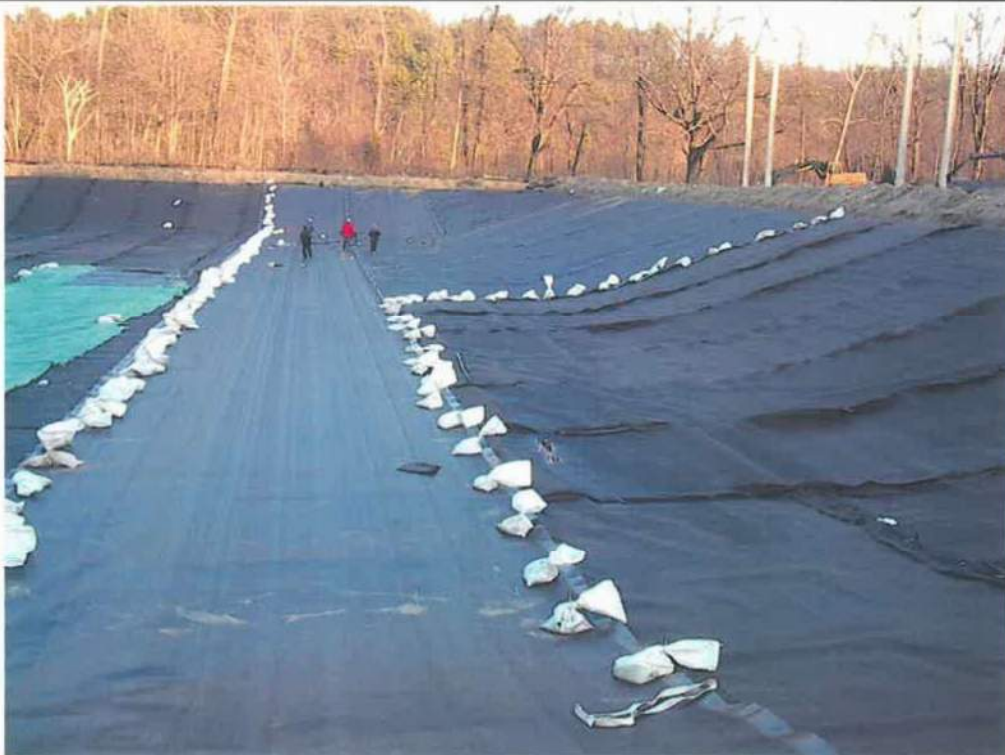
Photo 16 - Deployment of 60 Mil HDPE liner viewing the south slope from west to east

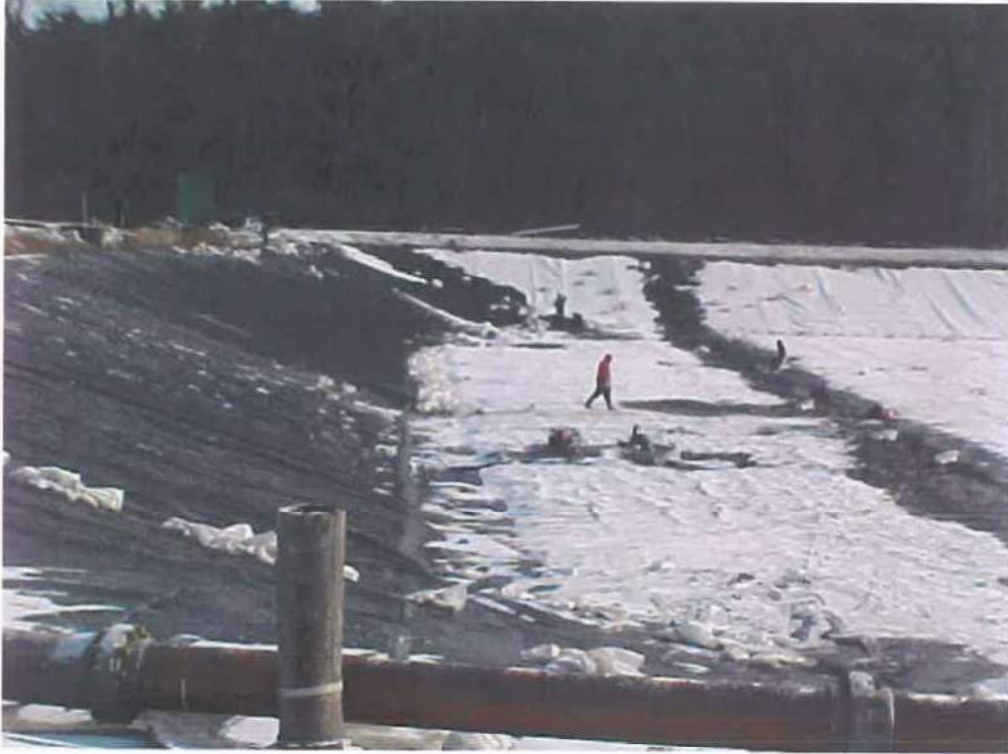
Photo 17 - Completed 60 Mil HDPE liner along the north slope viewing from west to east

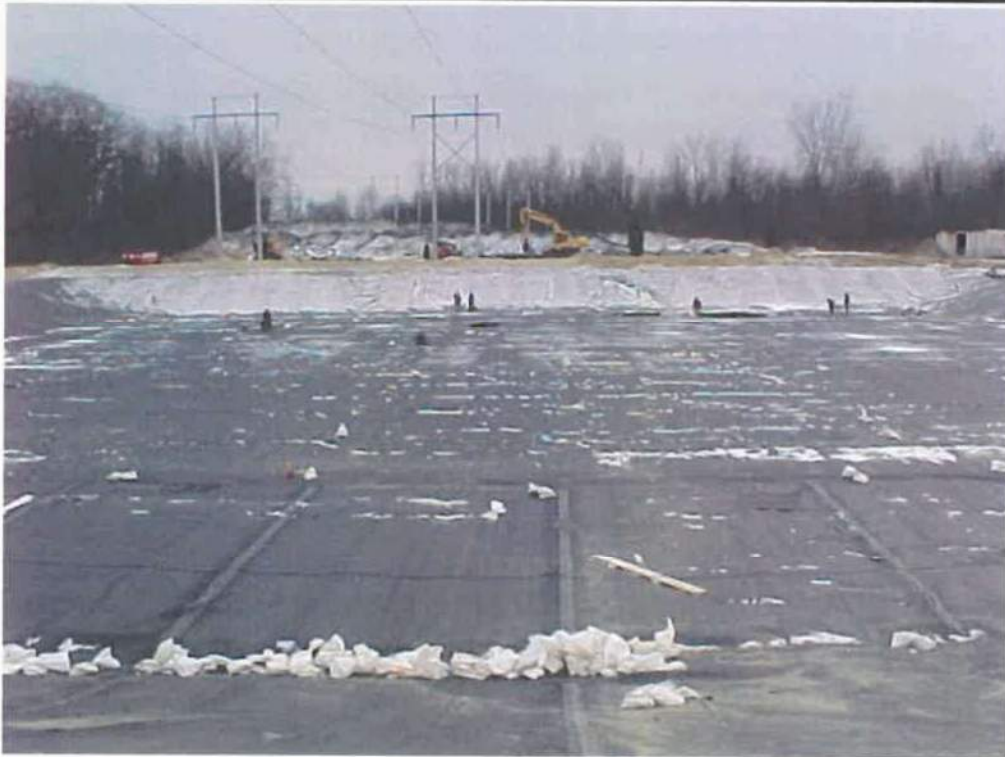
Photo 18 - Completed 60 Mil HDPE liner viewing from north to south
